SI M33 01 14
Rear Axle

SB-10056090-1237

Delivery Stop/Service Action: Shock Absorber Rear Axle

F56 (MINI Hardtop)

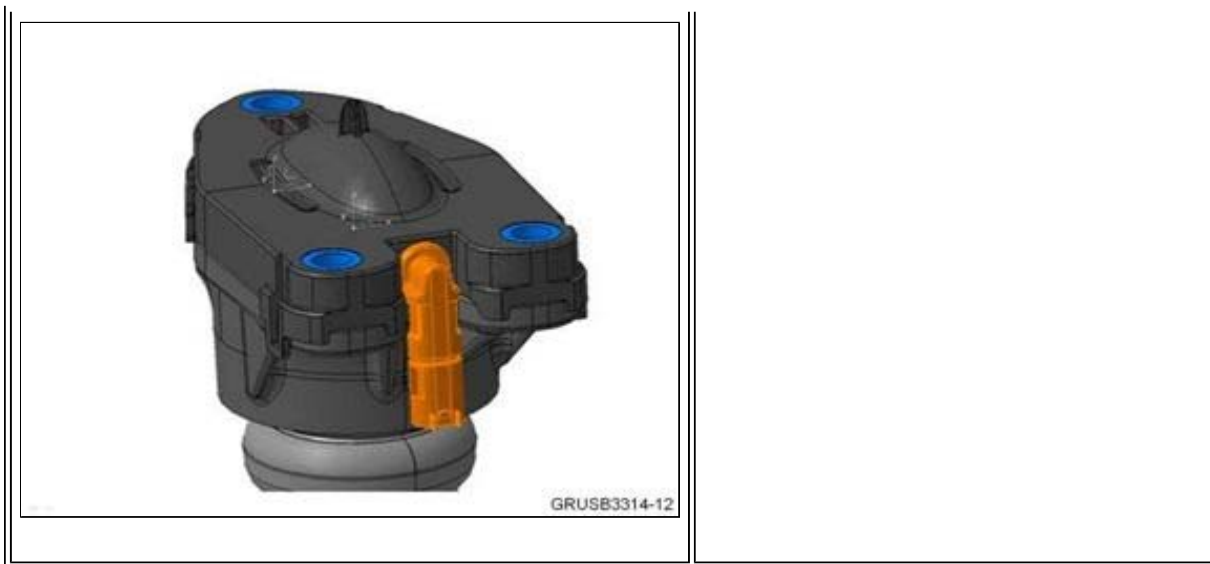
<p>Turn both plugs in the installed position. Push them down until they snap into place.</p>
	<p>Fit the adapter plate</p>
