Program Bulletin

SB-10056151-3195

SUBJECT: Seat Mounted Side Impact Airbag Connector

**MODELS: 2014 Chevrolet Silverado 1500
 2014 GMC Sierra 1500**

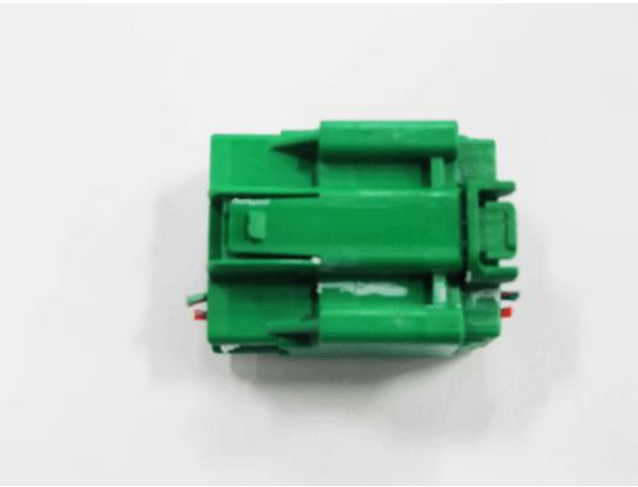
3957384

14. Moving to the driver seat, locate the outboard green SIAB harness connector (1) on the underside of the seat cushion.

15. Repeat steps 2 – 13 on the driver side wiring harness.
