Program Bulletin

SB-10056214-9273

SUBJECT: Front Strut - Noise

MODELS: 2012-2013 Chevrolet Colorado
2013 Chevrolet Trailblazer

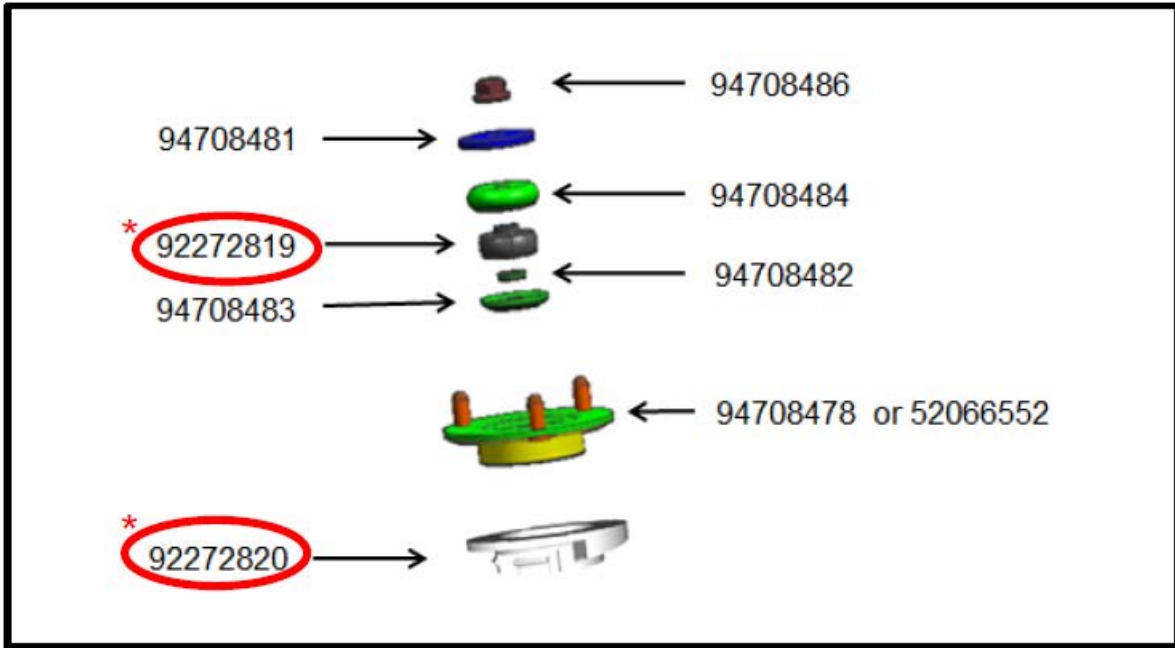
Service Parts Identification

Improved part – Change all of the affected VINs

Item	Part No	Quantity	Remark
Spring Seat Isolator (Improved part)	52057793	2	Replace all VINs
BUMPER, FRT S/ABS UPR ((LOWER) (Improved part)	92272819	2	Replace all VINs

P/N 94708478: Top mount bracket with Spring Seat Isolator - Old part number

P/N 52066552: Top Mount Bracket without Spring Seat Isolator – New Part number
