# UPDATE Technical Bulletin

## SB-10056475-8696

### UPDATE – 97AS Driver Seat Harness (NVLW)

Model(s)	Year	Engine Code	Trans. Code
Golf, GTI	2015	All	All

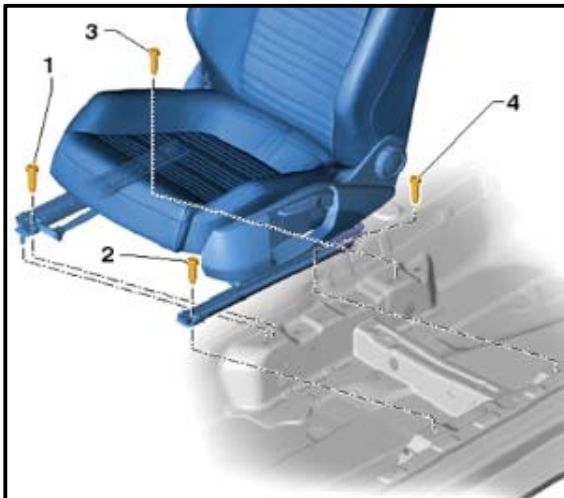
Tip: If rubber bands are found on the wire harness or seat frame <circles>, they can be removed and discarded.

- Move the driver front seat to the full forward position.
- ⇐ Remove the rear mounting bolts <3 and 4>.
- Move the seat to the full rearward position.
- ⇐ Remove the front mounting bolts <1 and 2>.
