RECALL CAMPAIGN BULLETIN

NTB14-092

VOLUNTARY EMISSION RECALL CAMPAIGN 2008 – 2010 ROGUE SULEV SPECIFICATION ECM REPROGRAM

APPLIED VEHICLES: 2008 - 2010 Rogue (S35) SULEV specification

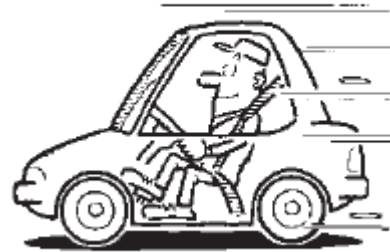
Figure A

- Most instructions for reprogramming with CONSULT-III plus (C-III plus) are displayed on the CONSULT PC screen.
- If you are not familiar with the reprogramming procedure, click [here](#). This will link you to the "CONSULT- III plus (C-III plus) Reprogramming" general procedure.
- Take the vehicle for a 10 minute drive in order to meet the following Idle Air Volume Learn (IAVL) conditions:
 - Engine coolant temperature: 70 -100°C (158 -212°F)
 - Battery voltage: More than 12.9V (At idle)
 - Transmission: Warmed up

- After reprogramming is complete, you will be required to perform Throttle Valve Closed Position, Idle Air Volume Learn, Accelerator Closed Position, and DTC erase.
