SB-10056716-3131

Door Opens to First Stage While Driving

F15 (X5)

With option 323 (Soft Close)

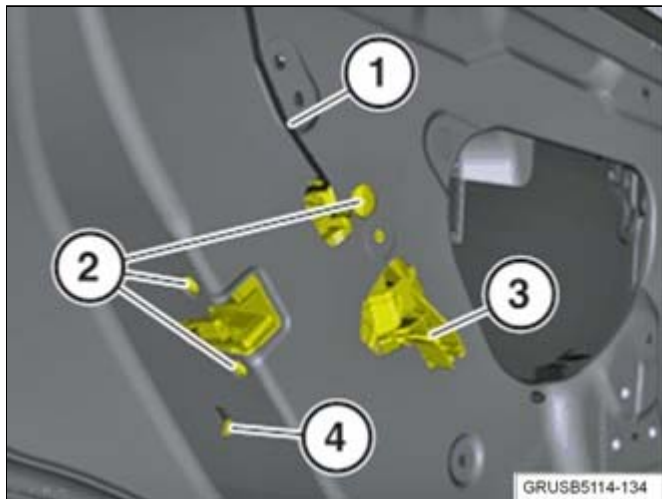
Do not damage the door lock seal when removing the door lock. Unclip the locking rod (1) and remove the screws (2). Remove the door lock (3) from the inside while supporting the outer door handle.

Check the date code on the door lock to see if it needs to be replaced as well. See step 21 below.

Any door lock with a date code older than 133602 must be replaced.

The repairs performed should be four new modified Bowden cable covers on all four doors and replacement of any door lock with a date code older than 133602. Once confirmed, reinstall all removed parts in reverse order of their removal.
