GROUP TRA	MODEL ≥ 2011MY
	NUMBER 055	DATE October 2014
TECHNICAL SERVICE BULLETIN		
SUBJECT: INHIBITOR SWITCH DIAGNOSIS INFORMATION

**SUBJECT: INHIBITOR SWITCH DIAGNOSIS INFORMATION**
**Service Procedure:**

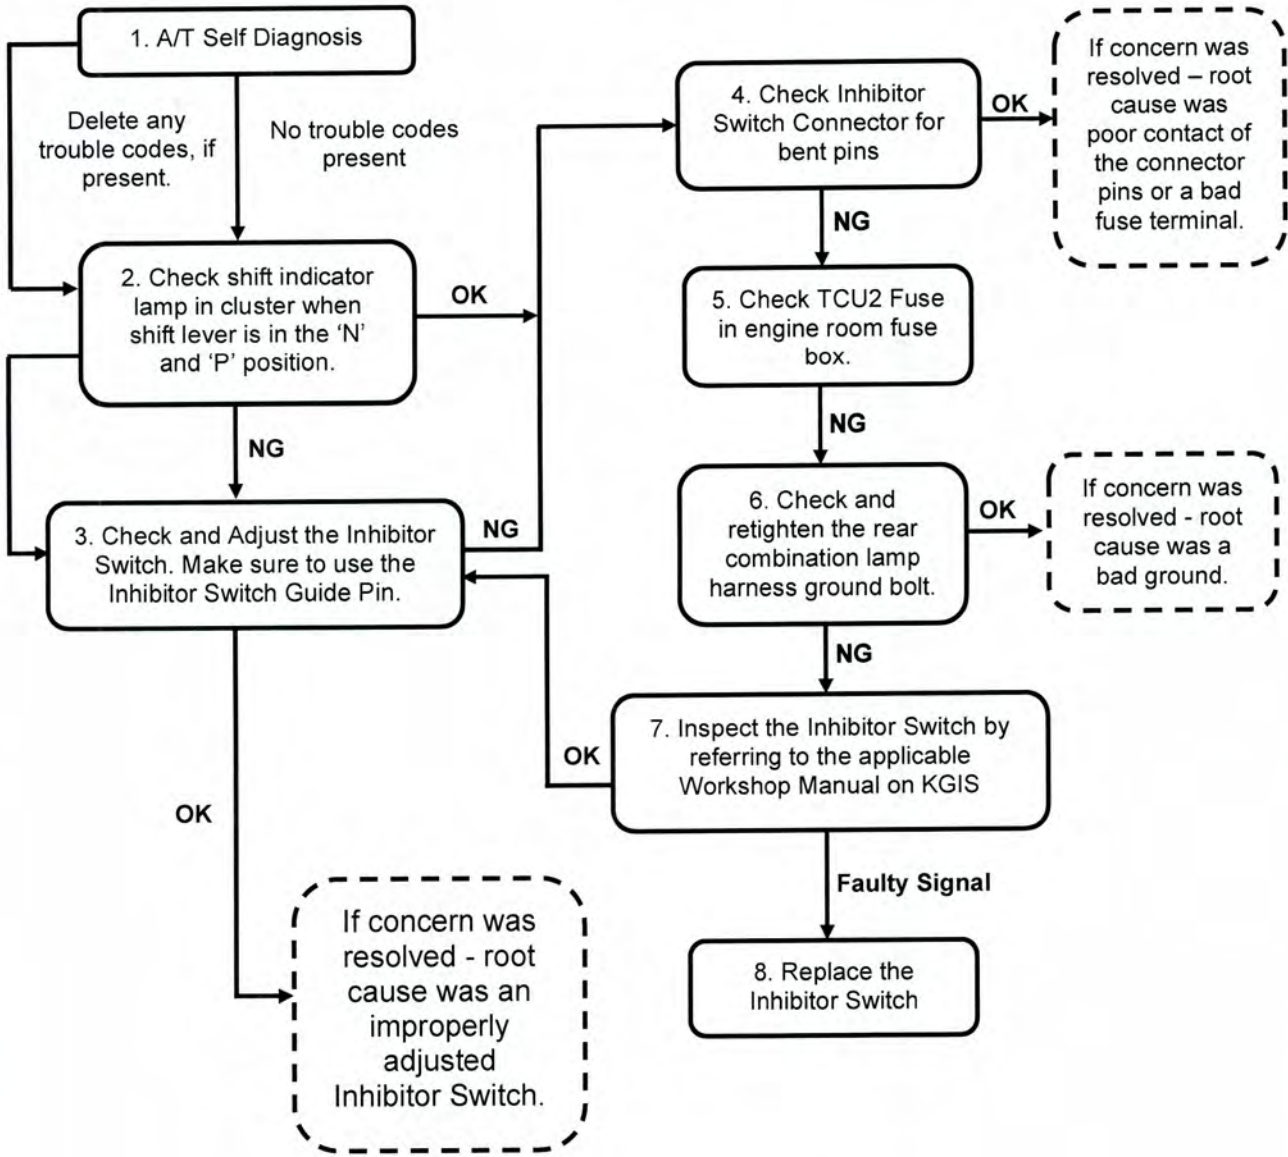
Diagnostic Flowchart:

All of the concerns listed above may be due to the Inhibitor Switch or related circuits not allowing the correct gear position signal to be sent to the TCM. This condition occurs more often following a heat soak, after long periods of driving in regions with high ambient temperatures or during the summer months. Attempt to duplicate the customer's concern as described in the repair order under the correct heat soak conditions.
