WARRANTY BULLETIN

CAN-AM® ROADSTER

Campaign no.: 2014-0010

Subject: **A - Fast Flasher Blink Rate**

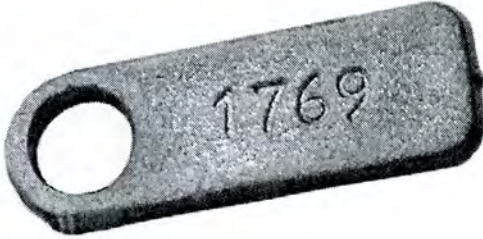
EXAMPLE - KEY TAG	LIST OF AFFECTED KEY TAGS

B - Possible Defective Ignition Key

A limited number of ignition keys may need to be modified. The potential failure may include:

- Unable to turn key in ignition switch
- Unable to remove key from ignition switch.

If the VIN is found in *SERIAL NUMBER LIST OF INVOLVED VEHICLES*, and the number on the key tag is found in the *LIST OF AFFECTED KEY TAGS*, carry out the *IGNITION KEY MODIFICATION* procedure. Refer to *PROCEDURE* in this publication.
