Program Bulletin

SB-10057642-8866

SUBJECT: ECM Wire Harness Contact

MODELS: 2014 Cadillac CTS
Equipped with 3.6L Twin-Turbo Engine (LF3)

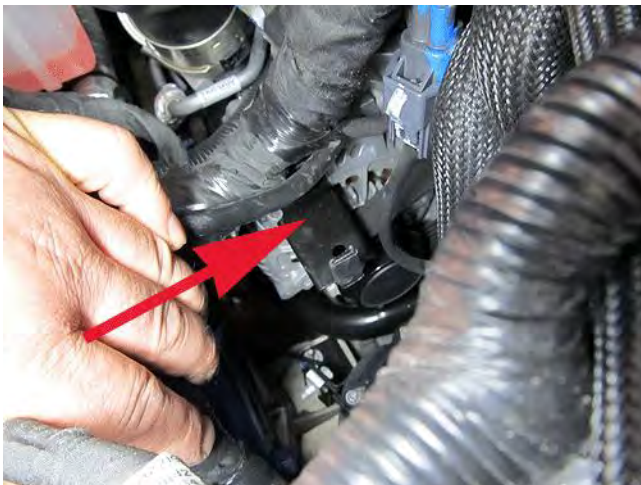
3905246

12. Inspect the wire harness conduit and insulation for damage where it contacts the bracket, repair as required. Refer to *Repairing Damaged Wire Insulation* in SI for repair instructions. The use of a mirror as, shown will, help in locating wiring damage.
