Service Action: Drive Module Harness Edge Protection

I12 (i8)

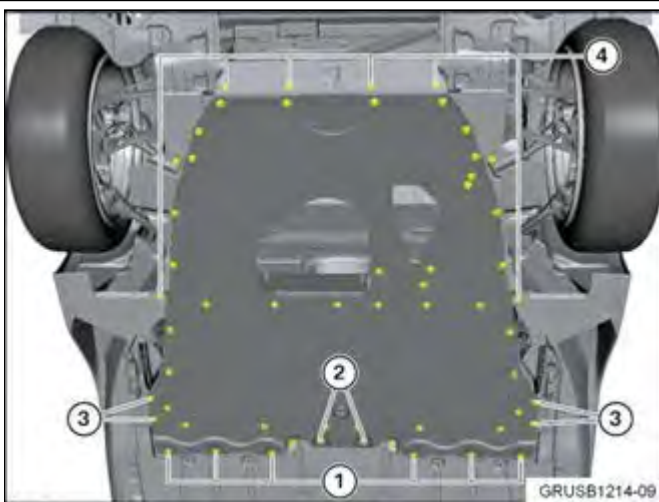
The wiring harness for the drive module (rear engine compartment) is routed in close proximity to the ISOFIX reinforcement bracket. During unfavorable conditions, the harness may rub against the bracket. Contact between the harness and bracket may produce a noticeable noise. With longer exposure, the bracket may rub through the corrugated tubing protecting the harness.

1. Raise the vehicle on a lift.
2. Remove the rear thrust plate per REP 41 11 440.
