Service Bulletin

Subject: INFORMATION DISPLAY SHOWS "FOW INSPECTION REQUIRED" AND DTC C1A67:78 IS STORED	Bulletin No: 01-016/14
	Last Issued: 07/08/2014

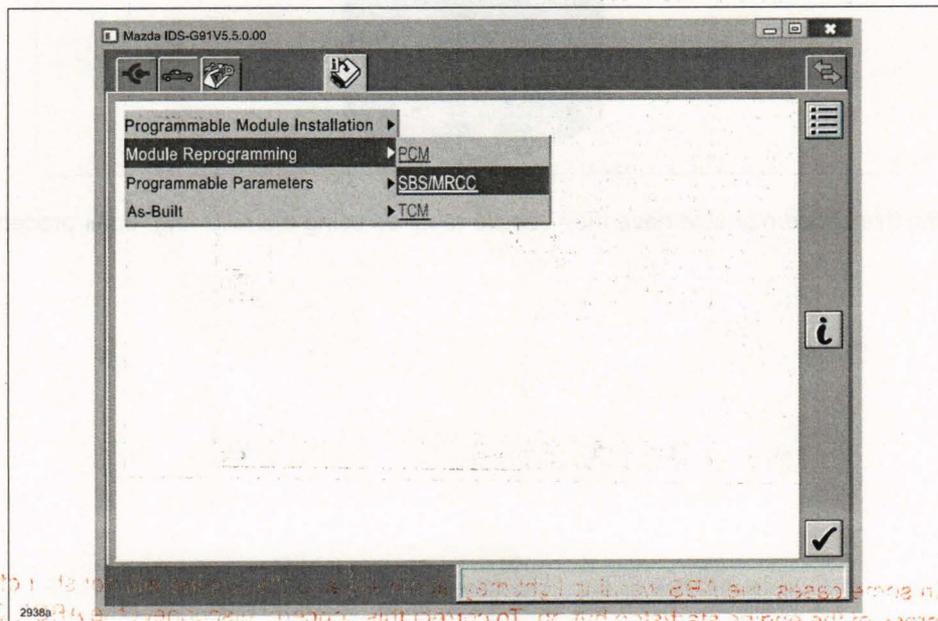
- a. Select "Module Reprogramming", then select "SBS/MRCC".

NOTE: The menu "SBS/MRCC" appears regardless of the equipment of MRCC System. For vehicles without the MRCC System, do not click this menu.
