09-001/14 – 2014 MAZDA3 - RATTLE, SNAP, POP OR CRACK NOISE FROM BOTTOM OF A-PILLAR

<b>Subject:</b> RATTLE, SNAP, POP OR CRACK NOISE FROM BOTTOM OF A-PILLAR	<b>Bulletin No:</b> 09-001/14
	<b>Last Issued:</b> 08/01/2014

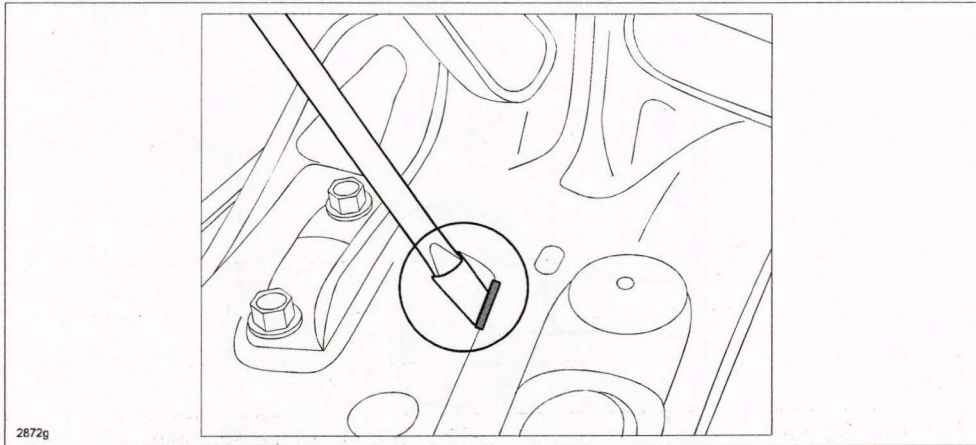
Area C for vehicles with VIN range JM1BM\*\*\*\*\*100001 - 189735

Some vehicles may exhibit a noise from the bottom of the A-pillar when driving on rough roads or over bumps. This is caused by the cowl upper plate and/or dash upper panel interfering with the wiper bracket. For the affected vehicles, a clearance needs to be created between the wiper bracket and cowl upper plate and between the wiper bracket and dash upper panel.

5. Apply a body adhesive to Area A between the wiper bracket and the dash upper panel (at the two locations shown).
