Service Bulletin

Subject: RATTLE NOISE FROM INSTRUMENT PANEL AND/OR CREAK NOISE FROM A-PILLAR OVER ROUGH / BUMPY ROADS	Bulletin No: 09-002/14
	Last Issued: 01/08/2014

2013-2014 CX-5

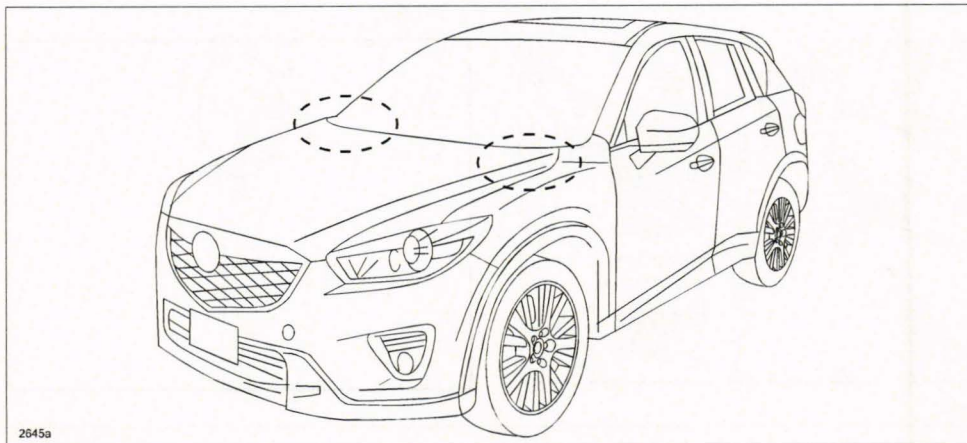
Rattle Noise From Instrument Panel:

While driving over rough or bumpy roads, some vehicles may exhibit a rattle noise from the instrument panel and/or a creak noise from the A-pillar.

The rattle noise may be caused by low cowl panel (A) mounting bolt (B) torque.

1. Remove the cowl grille according to the online MS3 instructions or the Workshop Manual (section 09-16 COWL GRILLE REMOVAL/INSTALLATION).
