DRIVER-SIDE POWER DOOR MIRROR VIBRATION

Bulletin No: 09-026/14

Last Issued: 06/10/2014

2013-2015 CX-5 vehicles with VINS lower than JM3KE*****465579 (produced before April 1, 2014)

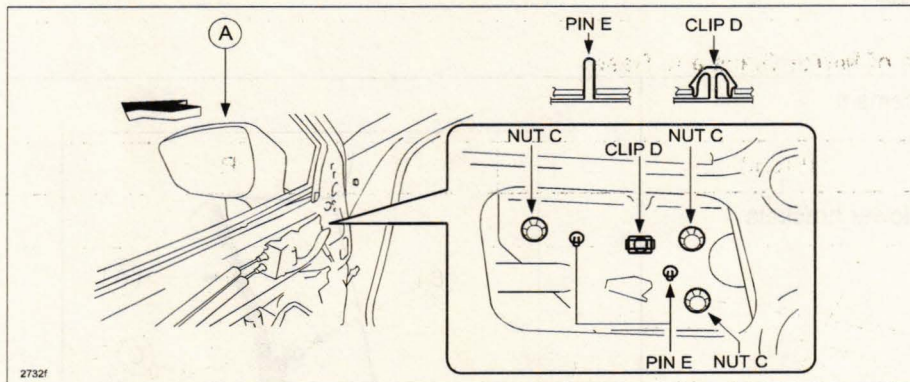
Nut Installation Type:

NOTE: Depending on when the vehicle was built, there are two (2) types of door mirror installations; a nut type and a bolt type.

2. Remove the power door mirror (A) according to the instructions on MS3 online or the Workshop Manual (section 09-12 POWER OUTER MIRROR REMOVAL/INSTALLATION).
