| HYUNDAI NEW THINKING. NEW POSSIBILITIES. Technical Service Bulletin | GROUP CAMPAIGN | NUMBER 14-01-039-1 |
| | DATE OCTOBER 2014 | MODEL(S) GENESIS SEDAN (DH) SONATA (LF) |
| SUBJECT: | NAVIGATION OPERATING SYSTEM SOFTWARE UPDATE (SERVICE CAMPAIGN TU2) | |

This TSB supersedes TSB# 14-01-039 to add 2015 Sonata (LF)

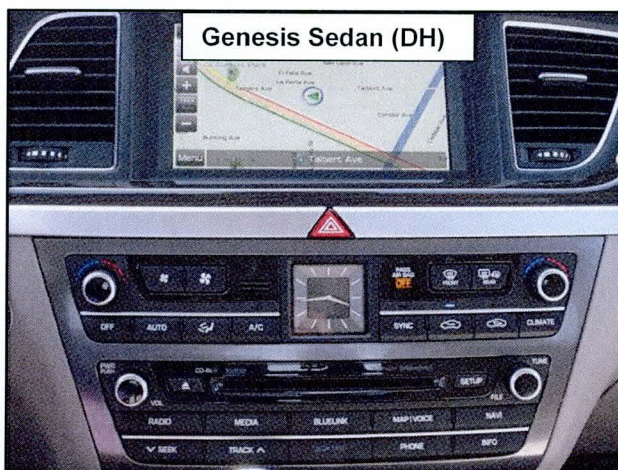
Page 3-8

- 2015 Genesis Sedan (DH) Equipped with Touchscreen only navigation system.
- 2015 Sonata (LF) Equipped with Touchscreen navigation system.
