Service Bulletin

Subject: SQUEAKING / GRINDING NOISE FROM REAR BRAKES	Bulletin No: 04-003/14
	Last Issued: 02/04/2014

2013-2014 CX-5 with VINs lower than JM3 KE*****401869 (produced before Oct. 9, 2013)

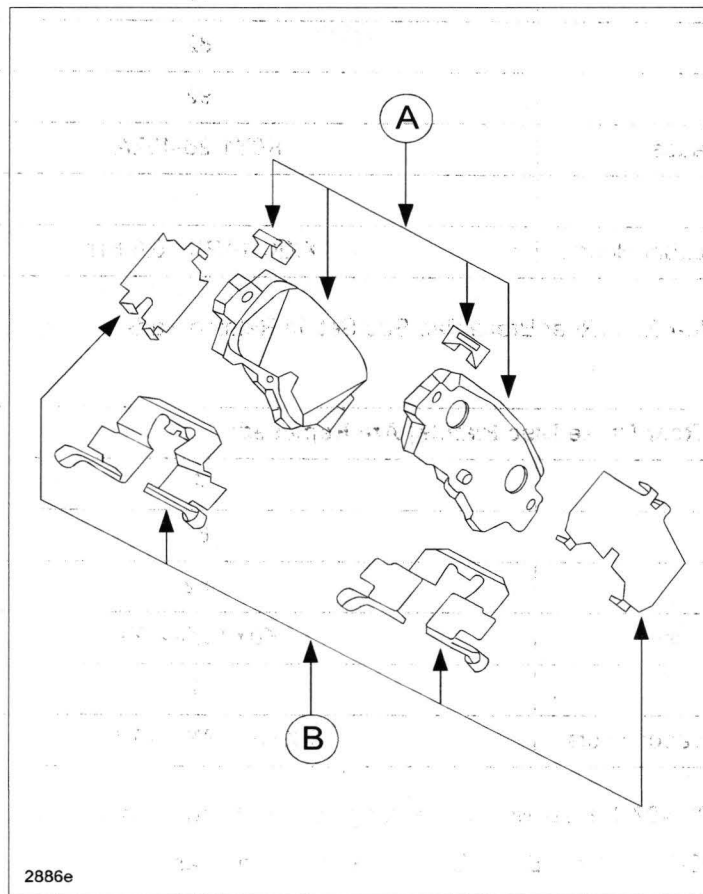
Part Number	Description	Qty.	Notes
K0Y1-26-48ZC	Rear Brake Pad Sub Set	1	(A)
K0Y1-26-49ZA	Rear Brake Pad Attachments	1	(B)
K011-26-251B	Rear Brake Disc Plate	1 or 2	Replace if necessary
