Service Bulletin

Bulletin No.: 12-06-04-003A

Subject: Malfunction Indicator Lamp (MIL) Illuminated, Reduced Engine Power Message Displayed, DTC P2135 Set

Models: 2009-2011 Buick Lucerne
2006-2008 Chevrolet Malibu
2006-2009 Chevrolet Uplander
2006-2011 Chevrolet Impala
2007-2009 Chevrolet Equinox
2006-2009 Pontiac G6
2006-2009 Pontiac Montana SV6
2007-2009 Pontiac Torrent
2006-2009 Saturn Vue
2007 Saturn Relay
2007-2009 Saturn Aura
Equipped with Engine — RPO LGD, LZ4, LZ8, LZE, LZ9, LNJ or LZG

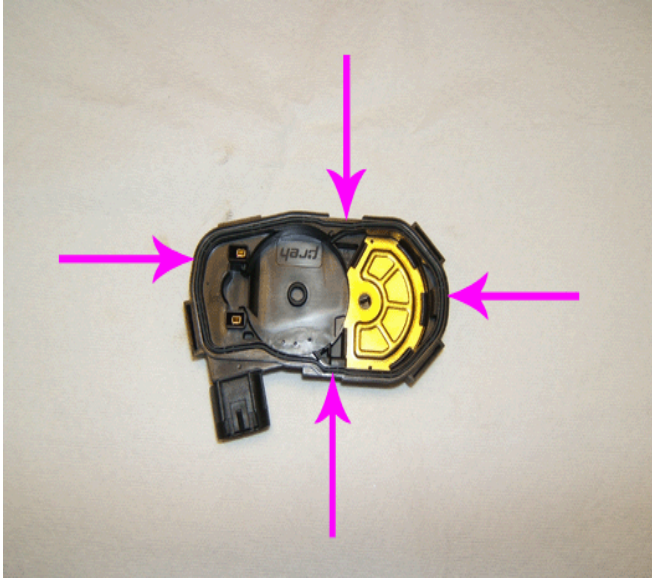
2910009

15. Place the TP sensor cover in the position as shown. Confirm the TP sensor drive slot orientation is aligned in the TP sensor cover as shown.

⇒ If the TP sensor drive slot orientation is not aligned as shown, use a small flathead screwdriver to gently rotate the TP sensor drive slot **clockwise** to the wide open throttle (WOT) position as shown.

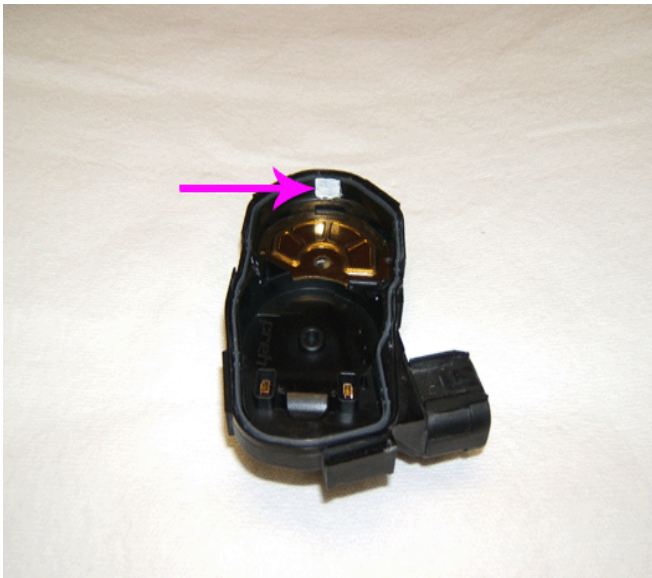
2910186

16. Verify that the TP sensor cover gasket is secure and properly positioned.
