# Service Bulletin

Bulletin No.: 14-06-01-002A

**Subject:** Crankshaft Rear Oil Seal — Oil Leak

**Models:** 2012-2013 Buick Enclave, LaCrosse  
2012-2013 Cadillac CTS, SRX  
2013 Cadillac ATS, XTS  
2012-2013 Chevrolet Camaro, Captiva, Equinox, Impala, Traverse  
2012-2013 GMC Acadia, Terrain  
Equipped with 6 CYL, 3.0L — RPO LFW  
Equipped with 6 CYL, 3.6L — RPO LFX or LLT

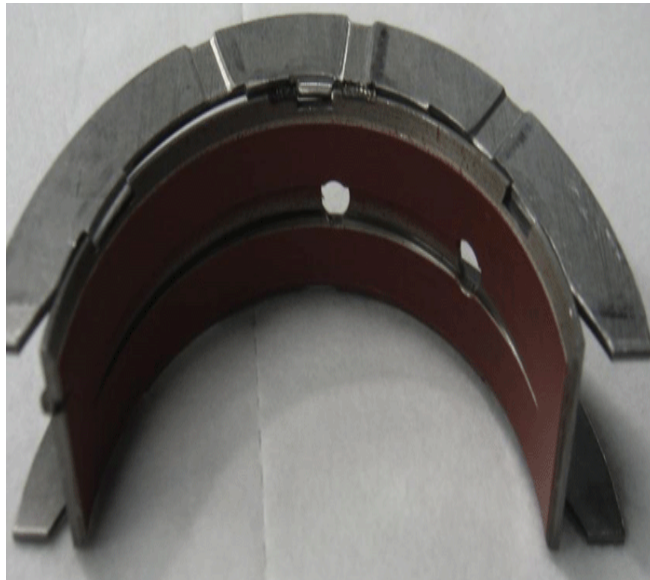
3959063

1. Perform the actions for the vehicle in order to remove the crankshaft rear oil seal and housing. Refer to Crankshaft Rear Oil Seal and Housing Replacement in SI.
2. Perform the actions for the vehicle in order to remove the oil pan. Refer to Oil Pan Replacement in SI.
3. Remove the bolts and the oil pan scraper from the oil pan and the oil pump suction pipe. Refer to Oil Pan Disassemble in SI.
4. Remove any gasket material or sealant from all oil pan and engine block gasket surfaces as needed, using the *EN 28410 Gasket Remover*. Clean the oil pan, oil pan scraper and oil pump suction pipe. Refer to Oil Pan Cleaning and Inspection in SI.
