Bulletin No.: 14176A
Date: September 2014

Recall Bulletin

SUBJECT: Improperly Crimped Accelerator Pedal Position Electrical Terminals

MODELS: 2014 Cadillac ATS

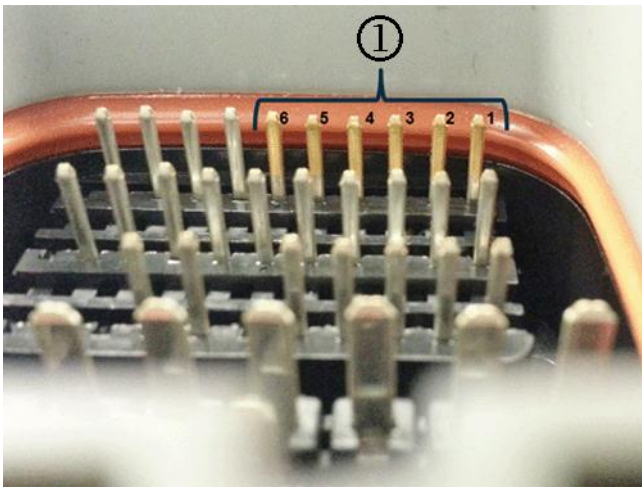
3942449

Caution: The Accelerator Pedal Position (APP) sensor circuits are cavities 1 through 6 within the X150 connector. All six terminals for APP must be gold plated.

7. Disconnect the connector and inspect the engine-side (male) terminals, 1 through 6 (1). As shown in the graphic above, the six terminals are gold and the surrounding terminals are tin.
 - If the Julian date code is **outside** the 182 – 187 range AND all six terminals are gold plated, no further action is required. Proceed to *Reassembly Procedure* below.
