Recall Bulletin

PRODUCT EMISSION RECALL

SUBJECT: Improperly Crimped Accelerator Pedal Position Electrical Terminals

MODELS: 2014 Cadillac ATS

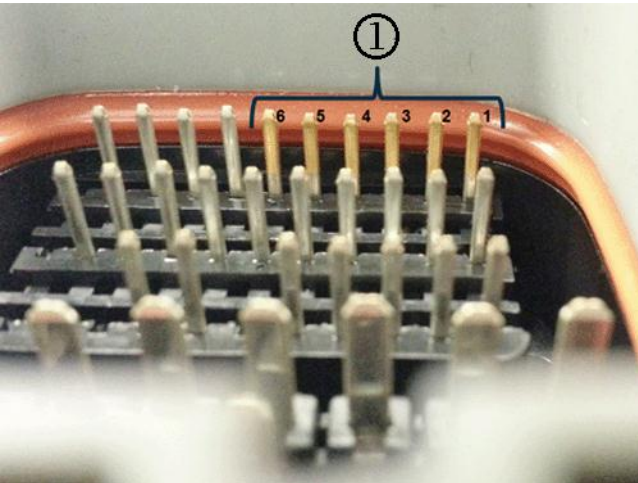
3942449

Caution: The Accelerator Pedal Position (APP) sensor circuits are cavities 1 through 6 within the X150 connector. All six terminals for APP must be gold plated.

7. Disconnect the connector and inspect the engine-side (male) terminals, 1 through 6 (1). As shown in the graphic above, the six terminals are gold and the surrounding terminals are tin.
 - If the Julian date code is **outside** the 182 – 187 range AND all six terminals are gold plated, no further action is required. Proceed to *Reassembly Procedure* below.
