PRODUCT CAMPAIGN BULLETIN

APPLICABILITY: 2003-2005 Subaru Legacy and Outback
 2003-2005 Subaru Baja
 2004-2005 Subaru Impreza
 (including WRX and STI)

NUMBER: WQM-49
DATE: September 2014
NHTSA ID: 14V-471

SUBJECT: Regional Front Passenger Air Bag Inflator Replacement

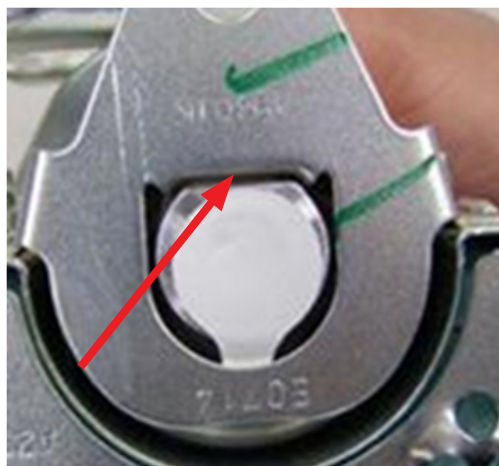
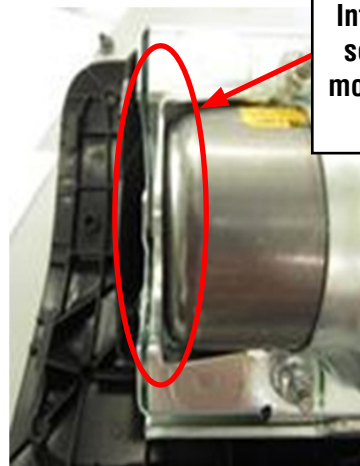
Inflator properly seated against mounting bracket (NO GAP)

STEP 9- Install the new inflator into the mounting bracket so the yellow taped end aligns with the removed stopper plate. Make sure the “D-shaped” portion of the inflator harness connector boss aligns with the “D-shaped” portion of the hole in the end of the mounting bracket as shown below. When properly installed, the end of the inflator will be seated tight against the mounting bracket. Do not peel the white harness connection dust cover at this time.

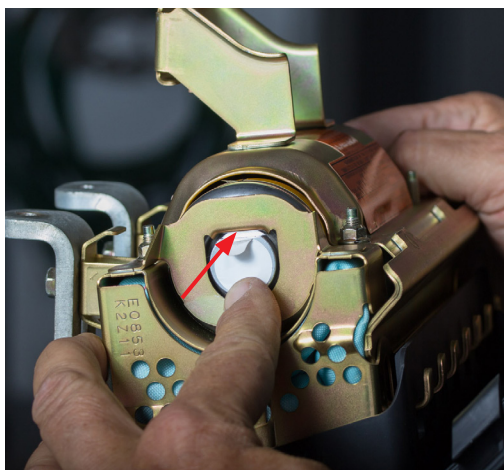
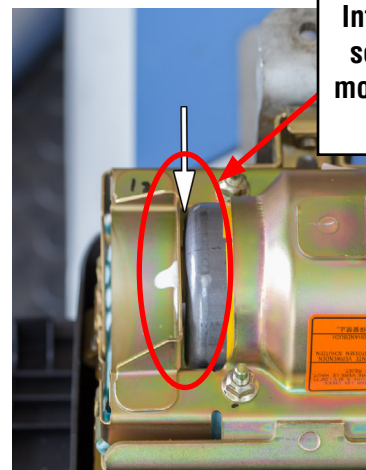
Inflator properly seated against mounting bracket (NO GAP)

STEP 9- Install the new inflator into the mounting bracket with the harness connector end going in first toward the mounting bracket. Make sure the “D-shaped” portion of the inflator harness connector boss aligns with the “D-shaped” portion of the hole in the end of the mounting bracket as shown below. When properly installed, the end of the inflator will be seated tight against the mounting bracket. Do not peel the white harness connection dust cover at this time.
