# Service Bulletin

## CUSTOMER SATISFACTION PROGRAM

**Subject:** 09132E – Power Steering Hose Leak (Program Expired)

**Models:** 2006 Chevrolet Impala, Monte Carlo (V6 & V8 Engine)  
2005-2006 Pontiac Grand Prix (V8 Engine)

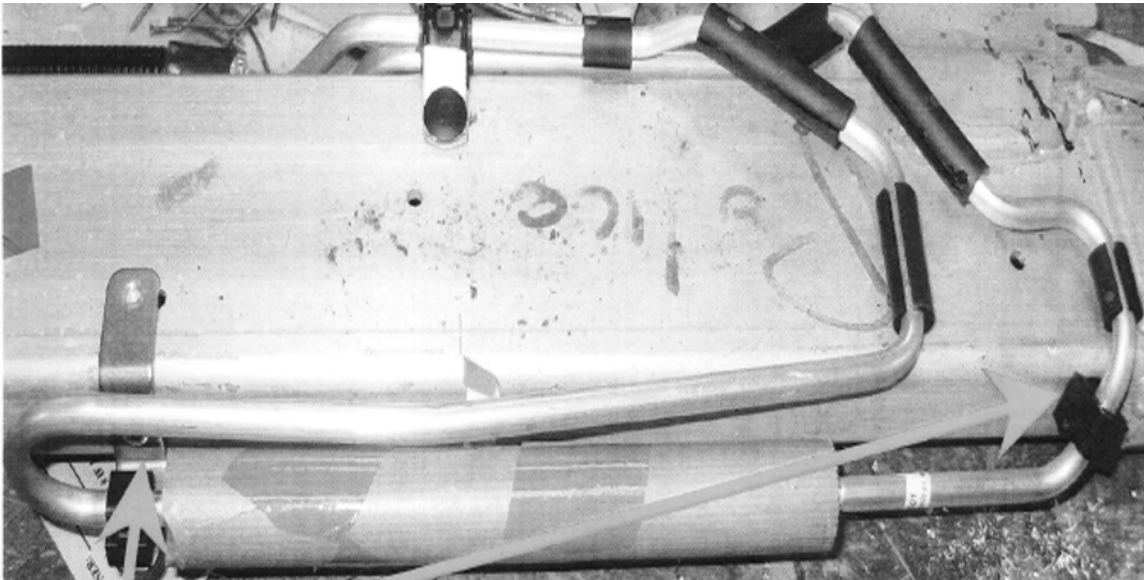
**Note:** The location of the leak (1) is shown above. Fittings on the hose are crimped socket and are not likely to leak.

- Two holes will be drilled for retro-fitting 2006 cradles with 2007 cooler pipe.
- Technician will need to remove one clip from cooler pipe on top and replace with isolator and move the other to the front face of the cradle (and replace with isolator).
- Technician will need to glue down the two isolators with Instant Adhesive-Gel, P/N 12345632 (US), 10953475 (CN), or equivalent, such as SAF-T-LOK IB-45 (ETHILCIANOCRILATO).
