Technical Bulletin

87 14 06 June 19, 2014 **2037255**

Whistle Noise from Center Vent Area; Blower Set On 3 or 4 with Full Heat Selected

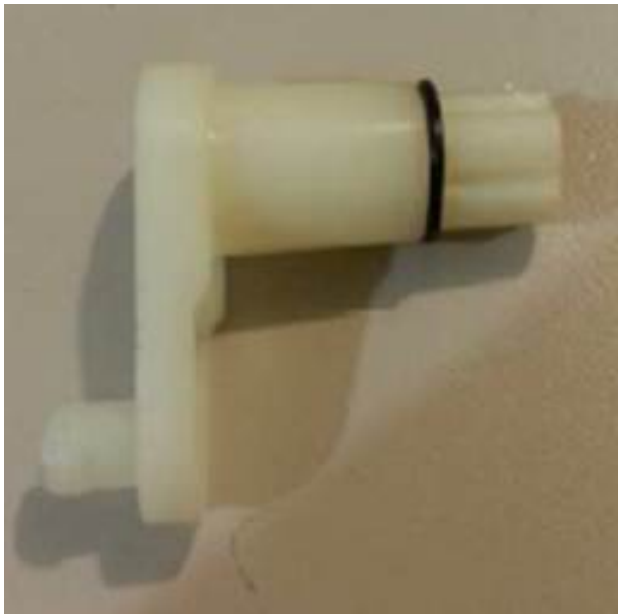
Installation of driver side temperature flap lever (White).

Set the temperature to full cold position to set the temperature flaps. This will aid in the installation.

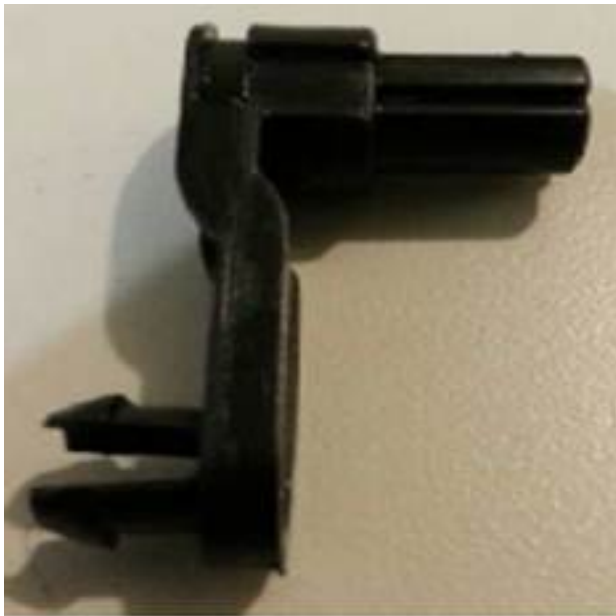
Installation of the passenger side temperature flap lever.
(Black)
