Service Bulletin

Bulletin No.: PIP5239

Subject: Commercially Available Tool For 1.2L LL0 Piston Installation

Models: 2013 - 2015 Chevrolet Spark
Equipped with 1.2L LL0

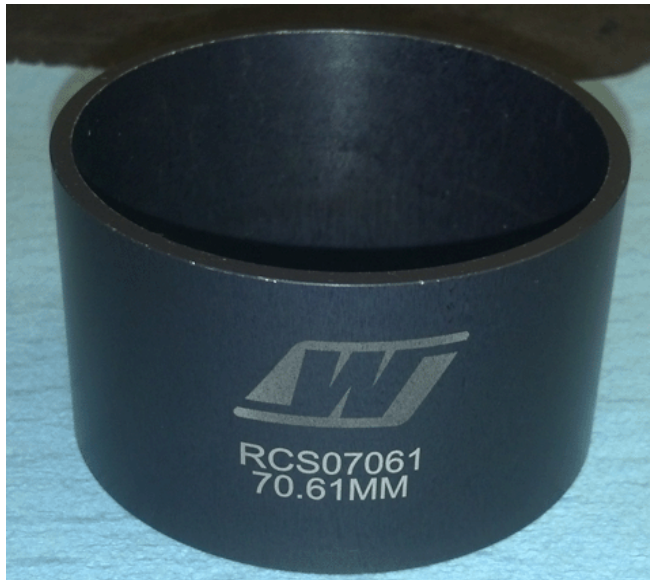
3999419

WISECO RCS07061 ring compressor sleeve.

The WISECO RCS07061 ring compressor sleeve is a cone style piston installer that will not allow the piston / ring assembly to pass if the piston rings are not properly positioned.

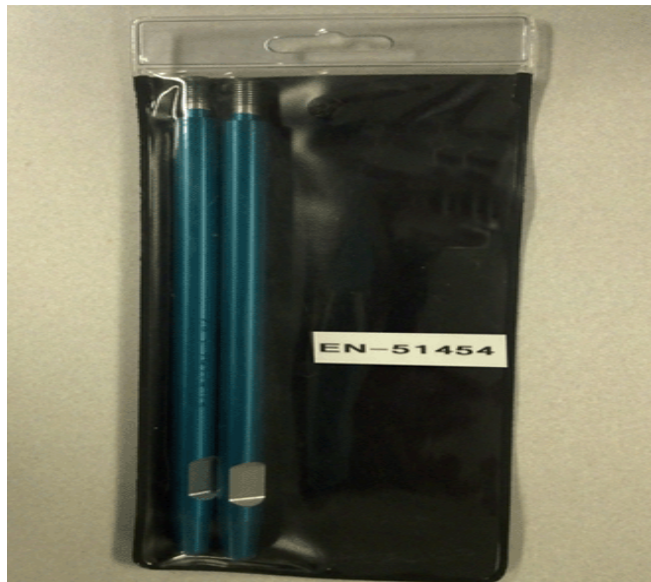
3999432

EN-51454 rod guide kit.

The EN-51454 rod guide kit is also available currently and will aid in the alignment of the piston rod to crankshaft rod journal during installation avoiding any incidental contact damage.
