TECHNICAL BULLETIN
LTB00596NAS2
04 FEB 2014

SECTION: 412-00

Climate Control System Drain Tube Incorrectly Located

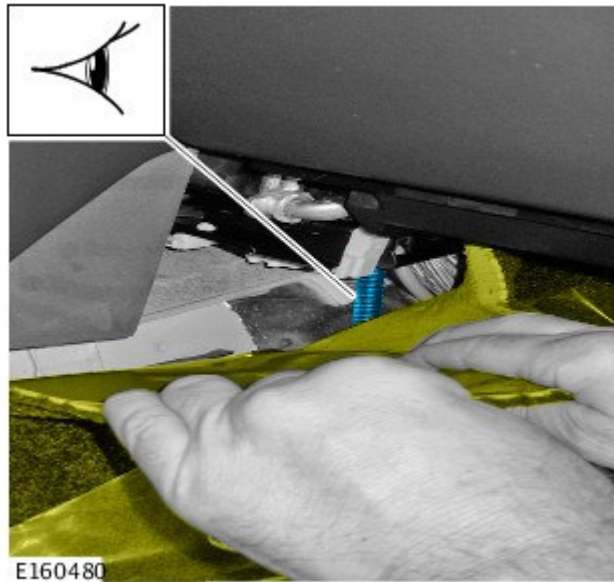
Cause: This may be caused by the Climate Control system drain tube being incorrectly located in footwell.

2. Pull the carpet down to expose Climate Control system drain tube.
