Service Bulletin

Bulletin No.: PI1315

Subject: Sunroof Rattle in Full Open Position

Models: 2014 Chevrolet SS
Built Prior to January 9, 2014

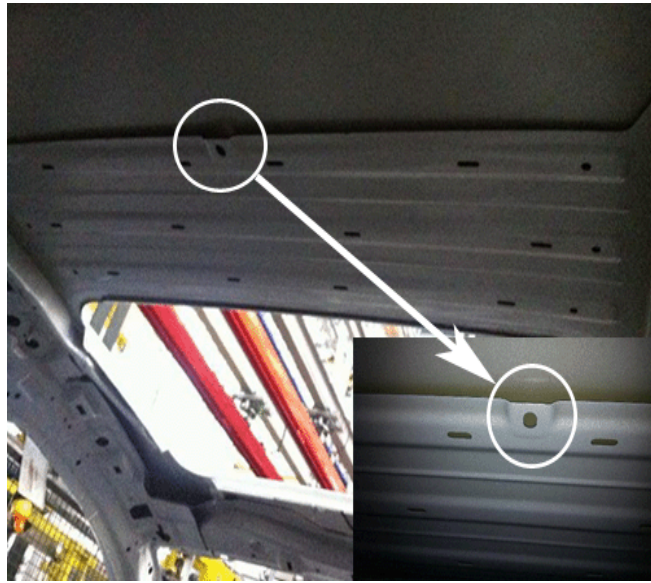
3971940

This may be caused by contact between the sunroof glass and the roof bow immediately rearward of the sunroof opening when the sunroof is in the fully open position.

7. Slide the sunroof blind forwards to expose the roof header immediately rearward of the sunroof opening.
8. From the right hand side of the vehicle, apply cloth tape to the roof bow.
