Seat Belt Bolts, Tighten MRU

FSB 884-007, Seat Belt Bolts, Tighten

(December 2014)

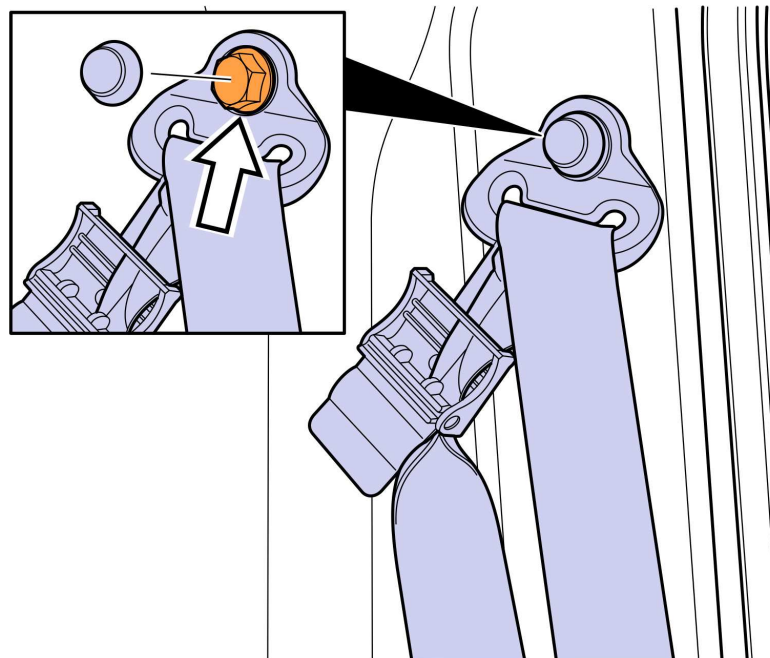
W8094422

On certain MACK MRU trucks manufactured from 06/04/2014 through 06/18/2014, the driver side seat belt bolts may loosen over time and potentially cause the seat belt to detach from the seat frame, cab wall, and cab floor. During seat belt installation, the tool used to install the seat belt bolts was out of specification, causing the application of a lower torque value than required. As a result of the lower torque values applied, the seat belt bolts may loosen over time and potentially cause the seat belt to detach. If this occurs, the seat belt may fail to restrain the occupant of the seat during the event of a vehicle crash.
