## Cab Harness Insulation, Installation CHU, CXU, GU, TD

### FSB 371-048, Cab Harness Insulation, Installation

(October 2014)

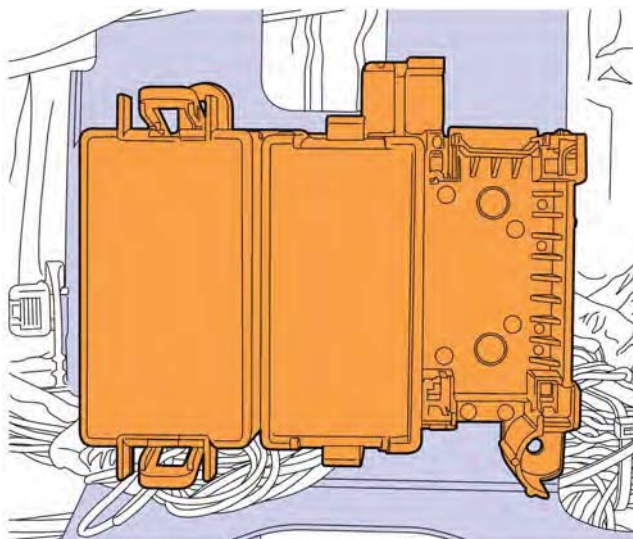
W3093298

**Note:** Removal of the fuse block will enable easy access to wiring on the left side of the steering column bracket.

- 5 Remove and reposition the fuse block.
