ID: IK1201113

Title: 2010 MaxxForce 11 & 13 and 2013 N13 HT EGR Core Removal/Installation

Applies To: 2010 MaxxForce11/13, 2013 N13, All Truck Models

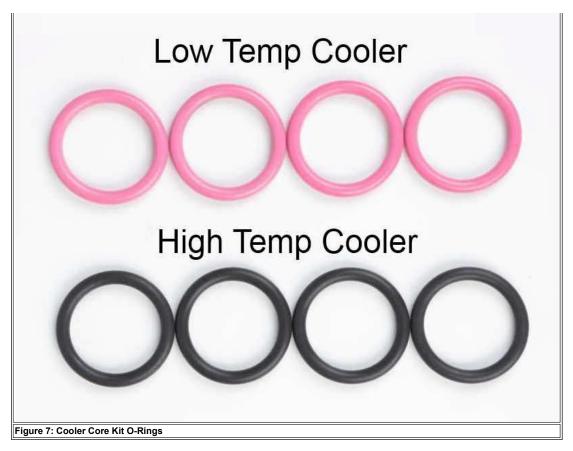
1. Install the four o-rings from the HT kit (Figure 6, Item 3) and ensure they are seated properly.

Make sure there is no debris in the o-ring grooves prior to installing the o-rings (they don't need to be spotless, just no soot chunks that will push the o-ring out of round). In development, this was the only instance of damaged o-rings (core outlet manifold cut off a section of the o-ring), outside of not actually seating them.

There are two o-ring designs and both are the same size with different durometers. Make sure to use only the black o-rings on the HT core and pink o-rings on the LT core.
