SERVICE BULLETIN

APPLICABILITY:	2010-2013MY Legacy and Outback
	Dan Cound from Dight Door Whool Anron A

SUBJECT: Pop Sound from Right Rear Wheel Apron Area

NUMBER: 12-147-13R DATE: 03/08/13 REVISED: 06/18/14

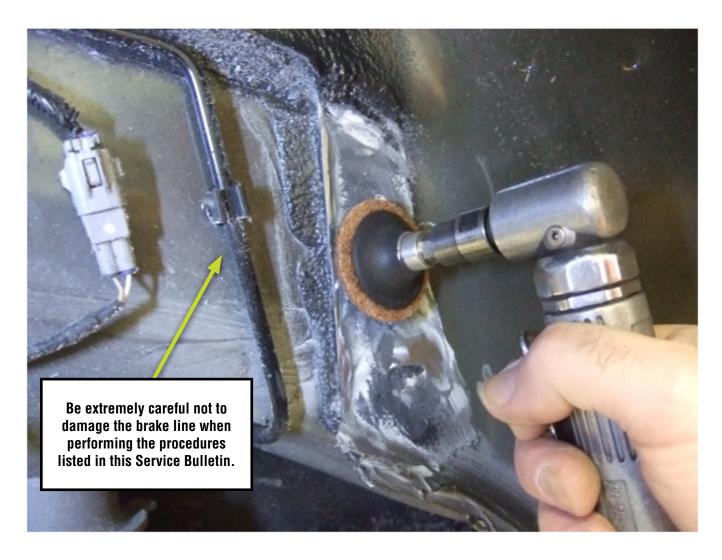
Photo of undercoating removed.

3. Remove the undercoating using a right angle disc sander and surface grinding disc. **NOTE:** Safety glasses and a respiratory mask should be worn when performing the procedures listed in this Service Bulletin.
