SERVICE BULLETIN

APPLICABILITY: 2013MY Legacy and Outback 2.5L Models
 2012-13MY Impreza 2.0L Models
 2013MY XV Crosstrek
 2011-2014MY Forester
 2013MY BRZ

NUMBER: 11-130-13R
DATE: 04/05/13
REVISED: 01/28/14

SUBJECT: Difficulty Starting, Rough Idle, Cam Position or Misfire DTCs
 P0340, P0341, P0345, P0346, P0365, P0366, P0390, P0391,
 P0301, P0302, P0303 or P0304

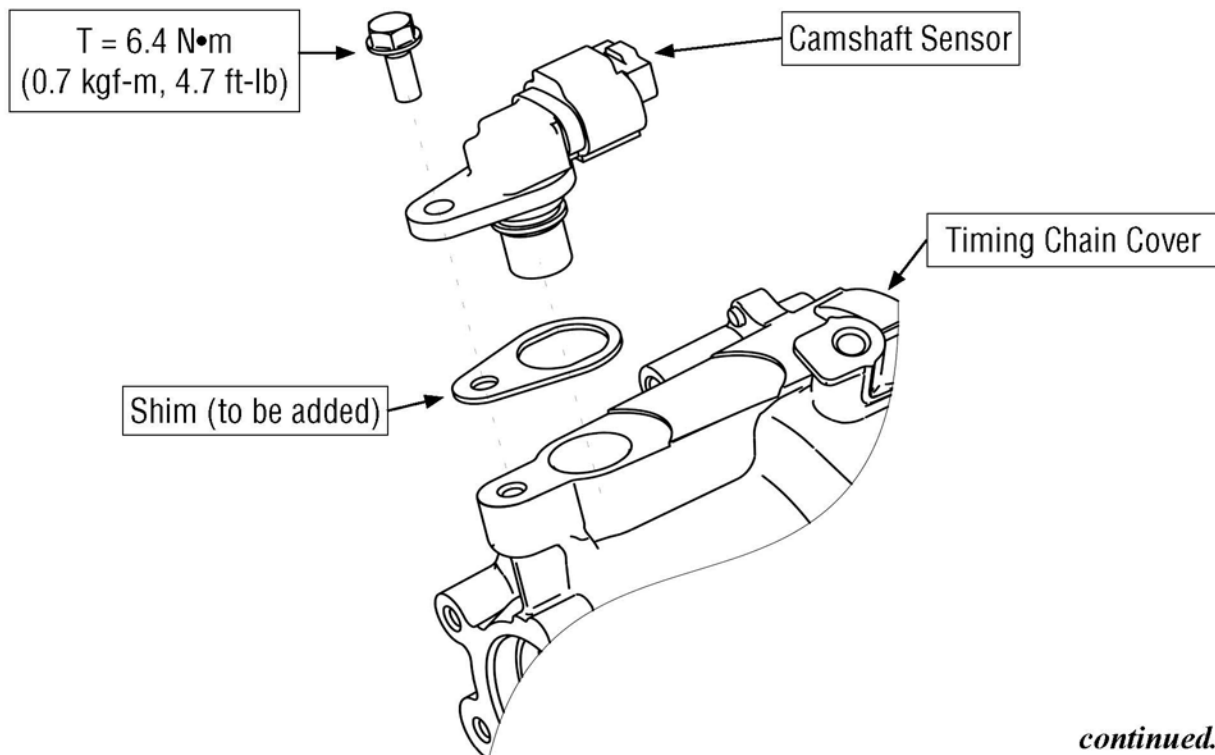
The specified clearance is 1.3 +/- .05mm (1.25 to 1.35mm or .049" to .053").

1. Record the customer's radio station presets (and navigation system favorites if applicable).
2. Disconnect the negative battery cable.
3. Remove the camshaft position sensor from the timing chain cover using the procedure in the applicable Service Manual.

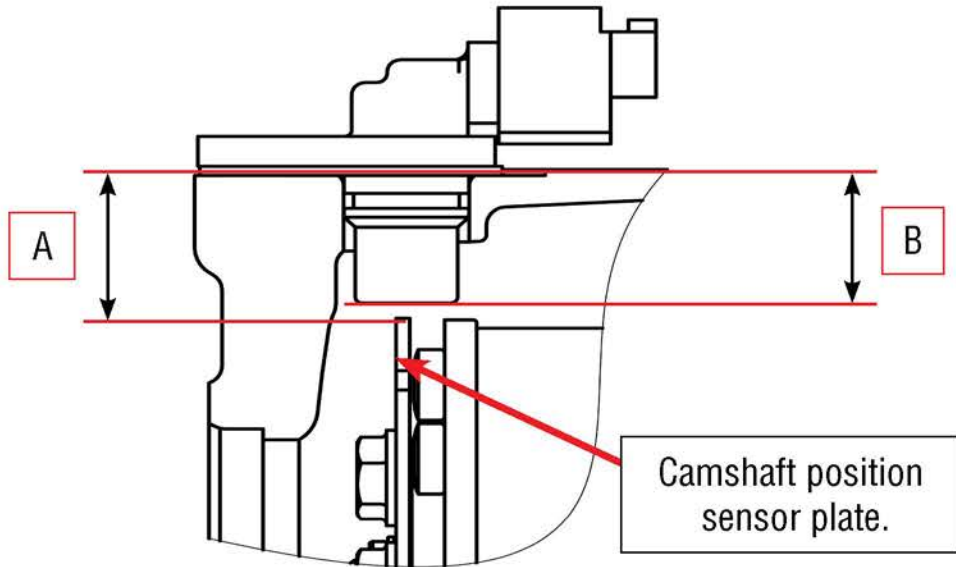
A = Top of timing chain cover to camshaft position sensor plate

B = Camshaft position sensor mating surface to the bottom of the sensor

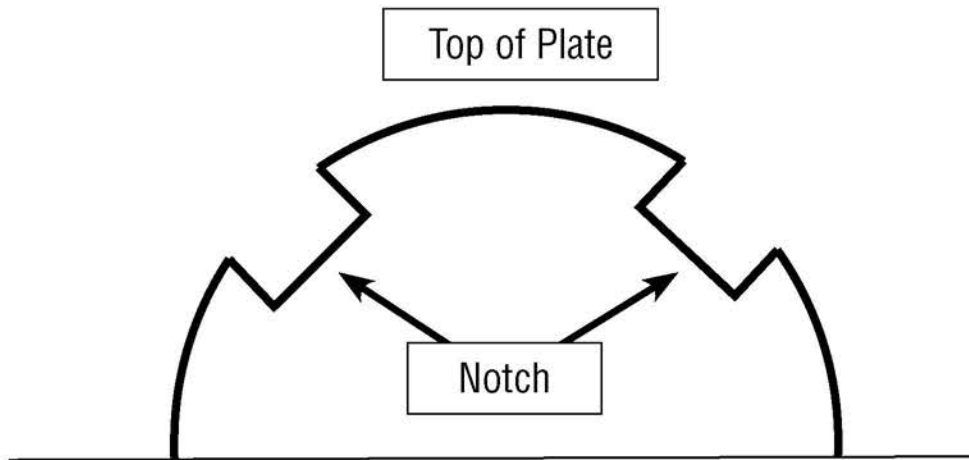
NOTE: When measuring “A”, make sure you are measuring to the outside diameter or “top” of the sensor plate and not to the bottom of a notch as shown below. Be sure to record all measurements.

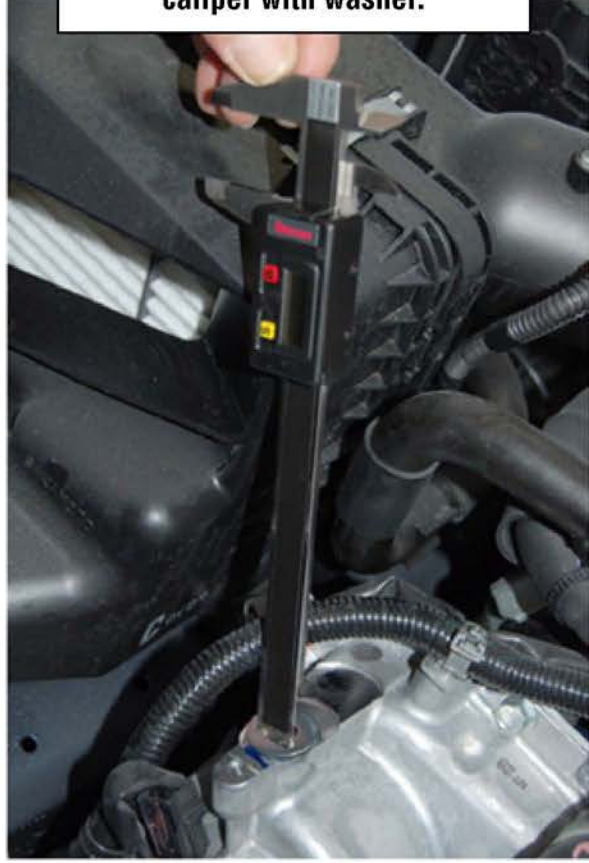
Measurement taken using digital caliper with washer.

IMPORTANT: When using the flat washer, make sure the washer is fully seated on the machined surfaces of the timing cover or your measurements will not be accurate.

1. Take a measurement and record the reading.
2. Using a breaker bar and 22mm socket, place the socket on the crankshaft pulley bolt and rotate the engine clockwise approximately 70°. **CAUTION:** Do not rotate the engine counter-clockwise, doing so will loosen the crankshaft pulley bolt. If the engine is accidentally turned counter-clockwise make sure the bolt is re-torqued following the proper procedure in the applicable Service Manual.
3. Take a measurement and record the reading.
4. Rotate the engine clockwise approximately 70°.
5. Take a measurement and record the reading.
6. Use the smallest of the three measurements and record the result.

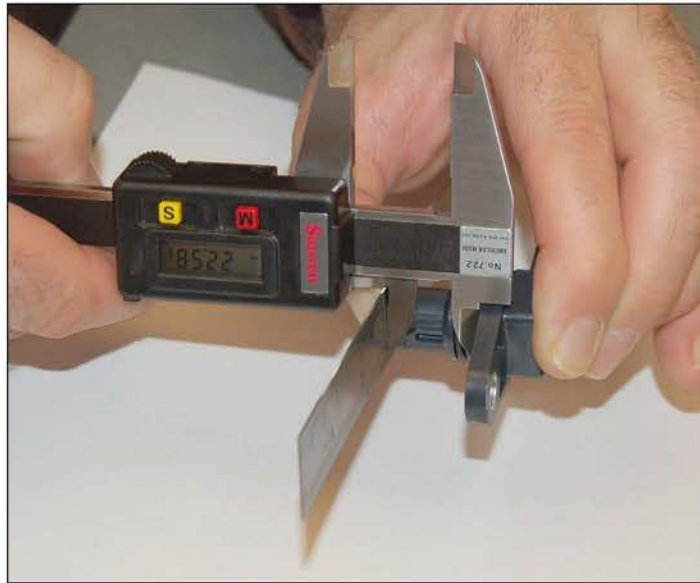
When taking measurement “B”, use a flat steel ruler or equivalent along with the digital caliper.

7. Measure the distance between the camshaft position sensor mounting surface and the bottom of the sensor as shown above.

IMPORTANT: Be sure to account for the thickness of the flat washer (if you are using one) when performing your calculations to determine the required shim thickness.
