**SERVICE INFORMATION**

**APPLICABILITY:** 2013-14MY BRZ

**NUMBER:** 07-86-14

**SUBJECT:** Vibration Sound from High-Mount Stop Lamp Assembly

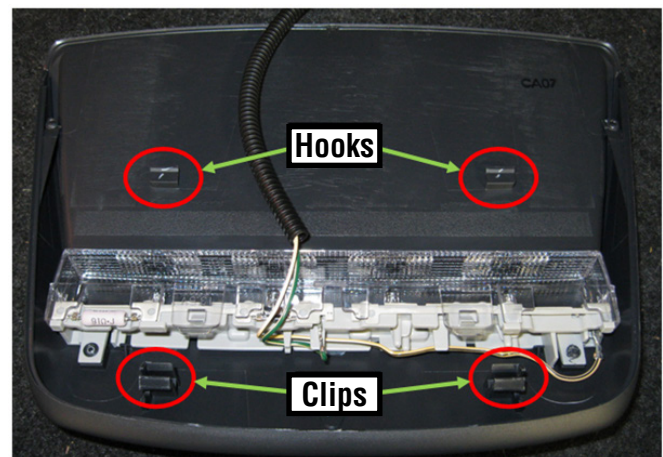
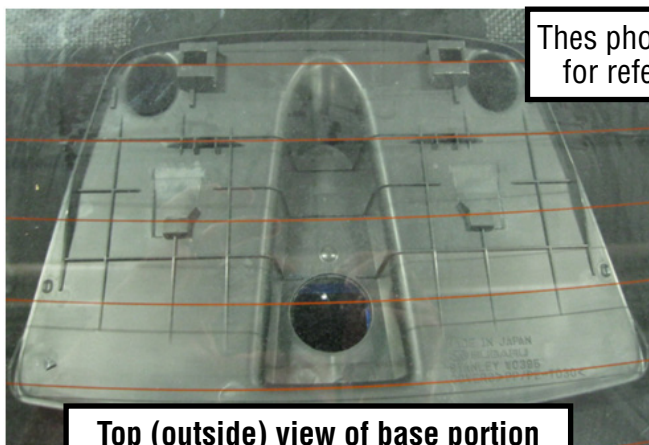
**Underside view of stop lamp**

**1 - Lift in the direction of the arrow to release the 2 retaining clips**

**2 - Slide the lamp assembly toward the front to disengage the hooks**

3. Reassembly is the reverse order of removal.
