Program Bulletin

CUSTOMER SATISFACTION PROGRAM

SUBJECT: **Seat Mounted Side Impact Airbag Connector**

MODELS: **2014 Chevrolet Silverado 1500**
 2014 GMC Sierra 1500

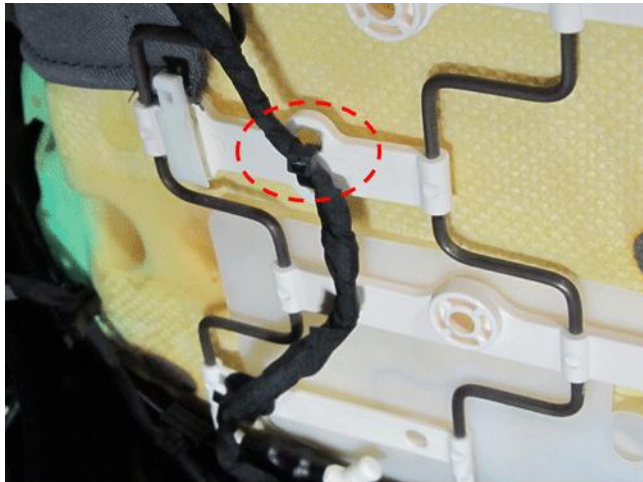
3957379

Note: The graphic above is for illustration purposes only to show the tie strap location. In this repair, the harness would have already had the yellow tape applied in the previous step.

13. Using the original mounting hole for the removed connector, secure the harness in position using a nylon tie strap.
