Title: ACM/DCU and DSI Faults Troubleshooting

Applies To: 2010 and 2013 (OBD) Emission DT, 9 & 10

This document is for troubleshooting the Aftertreatment Control Module(ACM)/Doser Control Unit (DCU) and Down Stream Injection(DSI) assembly on the 2010 and 2013 emissions DT/9/10 engines.

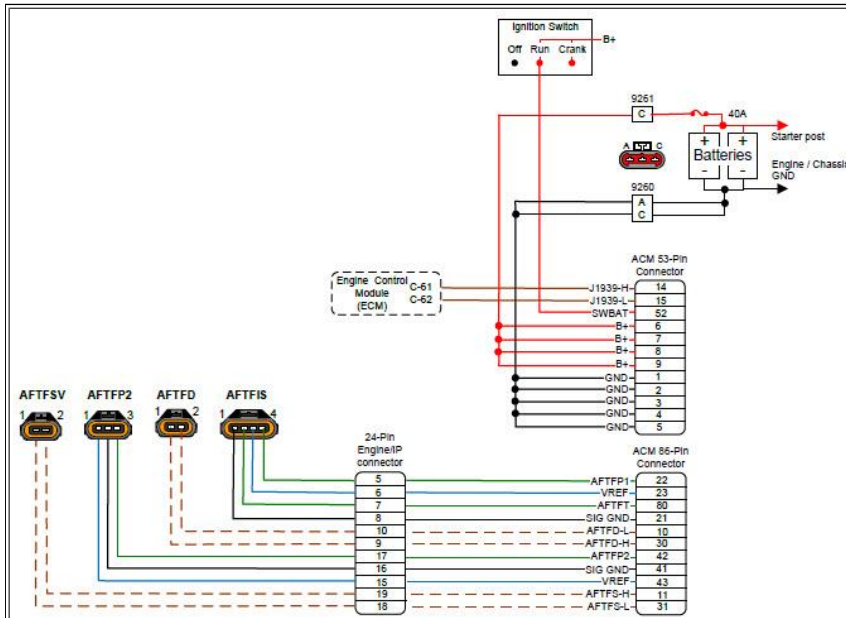
Figure # 1: MaxxForce DT/9/10 Aftertreatment wiring diagram

The ACM/DCU and DSI assembly should be thoroughly diagnosed before one is ever replaced. A majority of units with these codes are found to have wiring issues with the module or assembly. The following steps highlight areas that should be checked for wiring or connection issues.
