Service Bulletin

Bulletin No:	01-007/14
Last Issued:	04/03/2014

2009-2013 Mazda6 2.5L with automatic transmission

DESCRIPTION

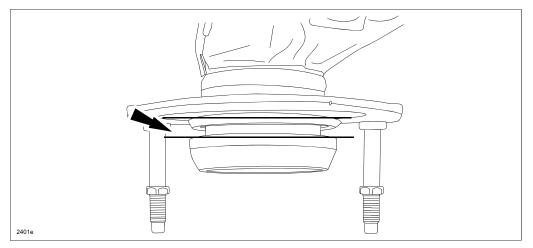
15. Replace old seal ring (A) with new seal ring (B). Push new seal ring (with yellow identification marking (C)) onto manifold flange by hand.

- Make sure seal ring fits straight and does not fall off when you remove your hand from the ring.
- Make sure seal ring fits straight, if not, there is a possibility the lubrication on the inner surface will be damaged when the seal ring is press-fitted with the special service tool.
- **CAUTION:** DO NOT APPLY any type of grease to the seal ring as it will harmfully effect the lubricant performance originally applied on the seal ring and the noise will recur.
