© 2014 Mazda Motor of America, Inc.

Subject: INFORMATION DISPLAY SHOWS "FOW INSPECTION REQUIRED" AND DTC C1A67:78 IS STORED	Bulletin No: 01-016/14
	Last Issued: 07/24/2014

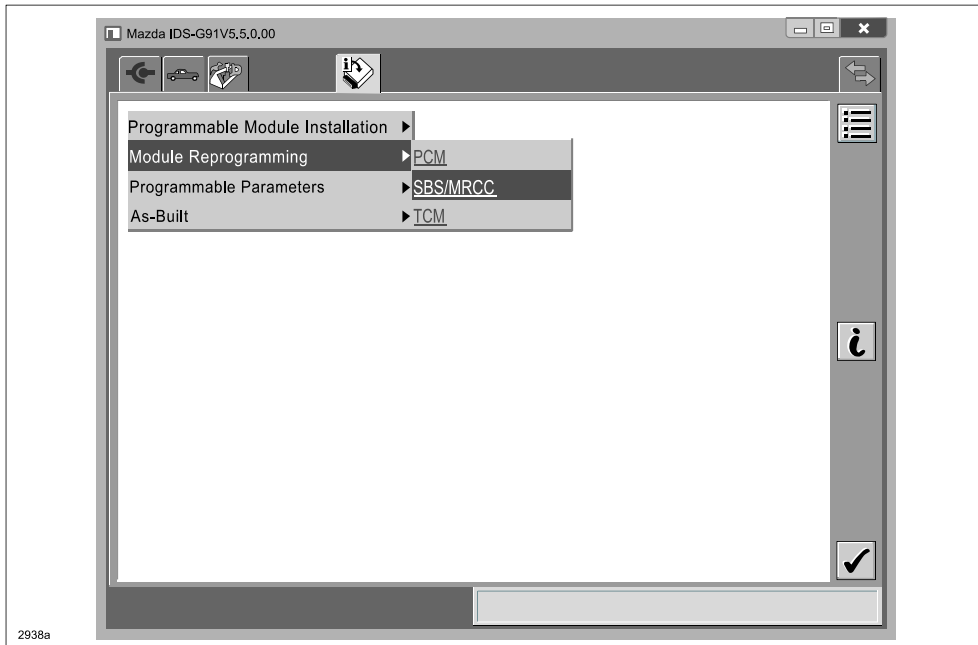
- a. Select “Module Reprogramming”, then select “SBS/MRCC”.

NOTE: The menu “SBS/MRCC” appears regardless of the equipment of MRCC System. For vehicles without the MRCC System, do not click this menu.
