Subject: REAR CONSOLE LID IS LOOSE	Bulletin No: 09-045/14
	Last Issued: 11/24/2014

2014-2015 Mazda6 vehicles with VINs lower than JM1 GJ ***** 186473 (produced before May 14, 2014)

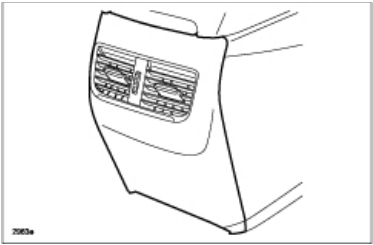
NOTE: The shape of the rear console panel has been changed, by adding a stopper rib to prevent the pin from coming off.

Part Number	Description	Qty.	Notes
GHR1-64-470A-02	Rear Console Panel	1	With Ventilation

4. Install a new rear console panel. (See PART(S) INFORMATION)
