TECHNICAL BULLETIN  
Q418 UPS6614-3bNAS1  
19 NOV 2014

Update Prior to Sale: Panoramic Roof Opening Panel / Blind Switch Function

**Range Rover Sport (LW)**

**Range Rover (LG)**

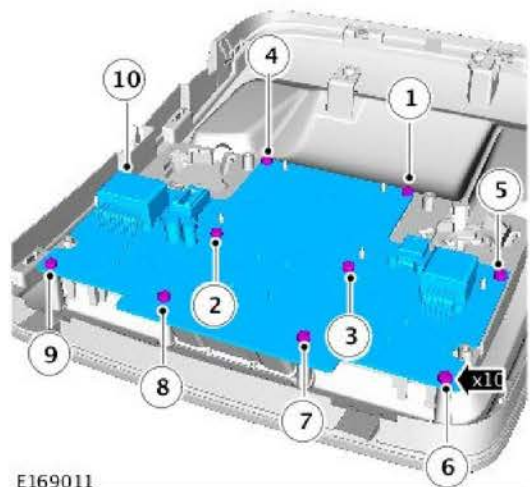
E169011

**NOTE: Hold from the edges of the printed circuit board (PCB).**

Remove the retaining screws in the sequence shown.

- Carefully remove the PCB.
