## ROADSTER 2015 Transmission Wiring Harness Incorrect Routing - Pinched Harness (F3 SE6)\_000109799\_MES61Y015S05\_en

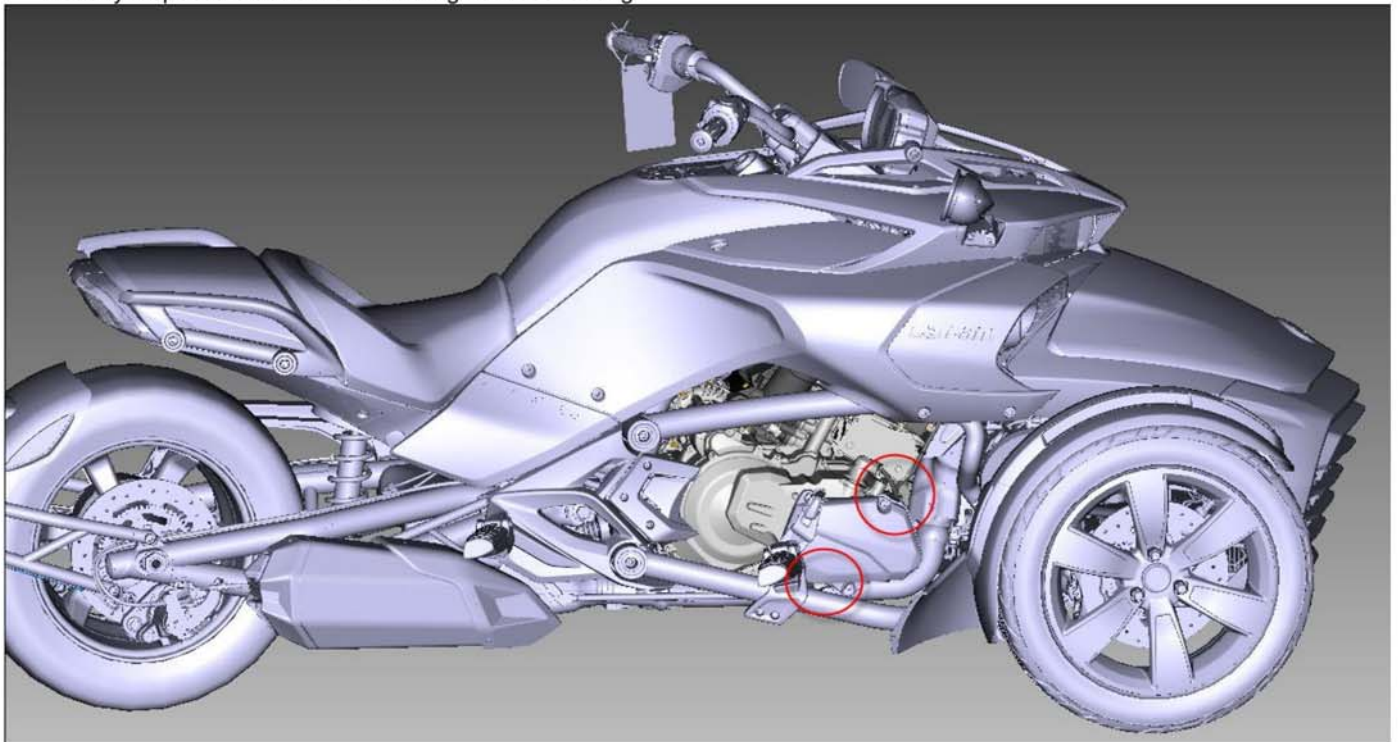
Front top harness correct routing

If upper or lower harness has the incorrect routing:  
Unscrew partially the plastic cover screws.  
Reposition wiring harness as specification per correct routing illustrations above..  
Tighten back plastic cover screws at 10 Nm +/- 2 Nm.
