INSTRUCTION TO SERVICE

ITS: 5907

SECTION:	231 Coolant System
WRITTEN BY:	Mike Pearson
SUBJECT:	Add Low Floor EMP Radiator Ground Straps

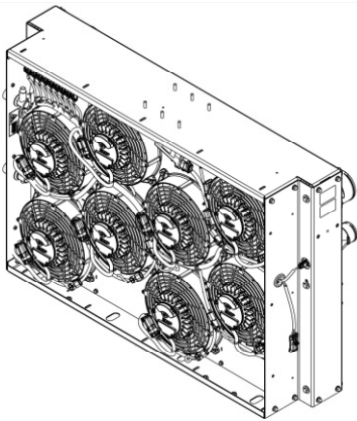
MH8 5034G FiL - TMC

Figure 1: Mini-Hybrid® Cooling Systems

Voltage potential between radiator and coolant pipes can be eliminated by grounding the Mini-Hybrid® cooling system and coolant pipes to the vehicle chassis.
