INSTRUCTION TO SERVICE

ITS: 5930	
SECTION:	231 Coolant System
WRITTEN BY:	Mike Pearson
SUBJECT:	Add EMP Radiator Ground Straps

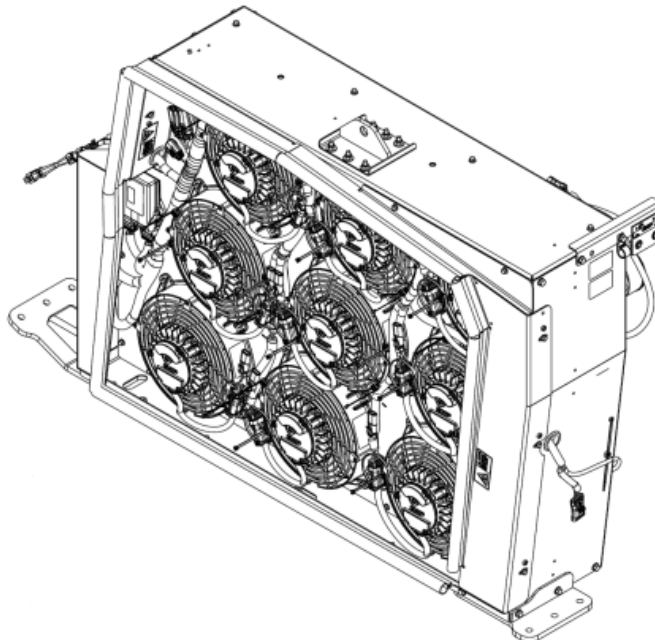
Figure 1: Mini-Hybrid® VPN 2020049001PA01 Cooling System

Radiator corrosion has been identified on buses with isolated pipe clamps on vehicles 2010 EPA or newer engines and Mini-Hybrid® cooling systems including:

Voltage potential between radiator and coolant pipes can be eliminated by grounding the Mini-Hybrid® cooling system and coolant pipes to the vehicle chassis.
