**NABI: WMATA – Exhaust Support Bracket**

**Property and TopBus Number:**  
WMATA 325000 & 325500 - Fleet Numbers: 8001 thru 8105.

**Issue:** Exhaust Support Bracket

Work Instruction Number:  
L3/FSV-321

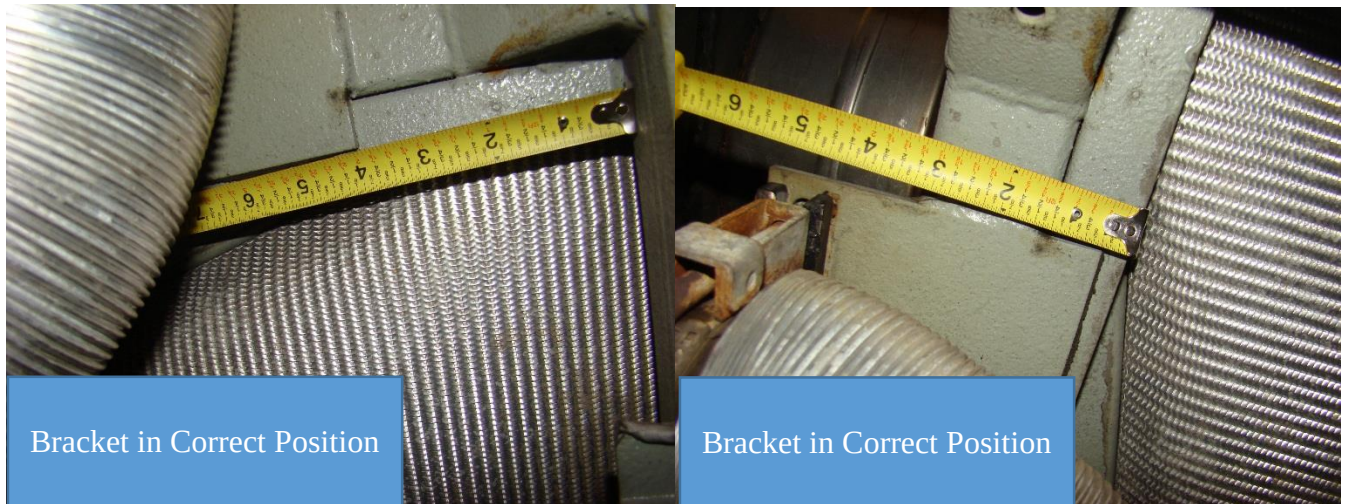
Check for  
cracked or  
broken welds.

6. If the welds are not cracked, broken & the bracket is in the correct position then only one weld needs to be added (see figure 2, step 25).
7. Remove the ground from the batteries.
8. Disconnect the electrical connection from the engine ECM.
9. Disconnect the electrical connections from Clever device.
10. Disconnect the electrical connections from the destination signs.
11. Disconnect the electrical connections from the ABS module.
12. Disconnect the electrical connection for the fire suppression bottle located in the upper engine compartment (see below).
