FOR LIMITED SERVICE CAMPAIGN FLB CERTAIN 2010 MODEL YEAR RX 450h OXYGEN SENSOR REPLACEMENT

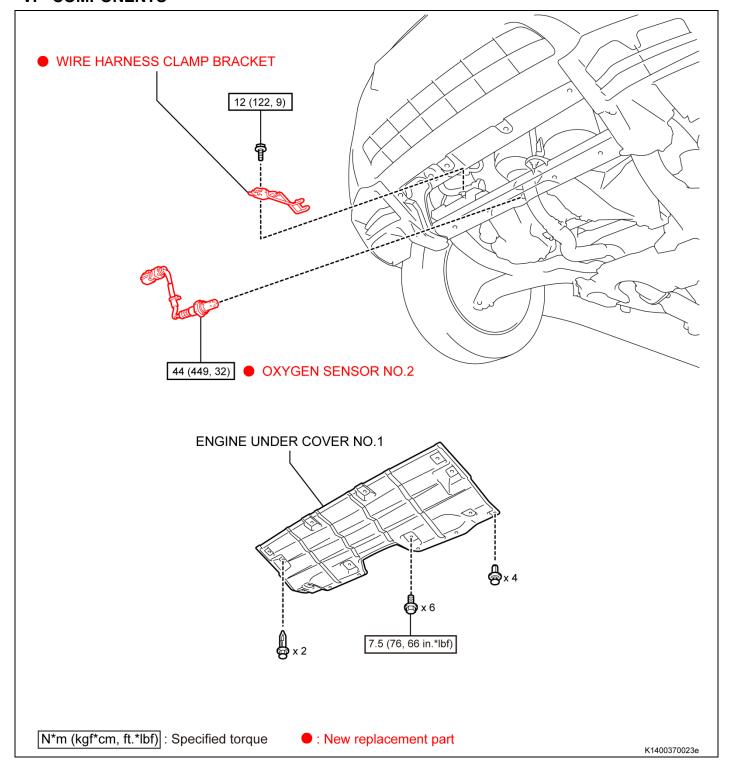
V. COMPONENTS

The subject vehicles are equipped with an oxygen sensor with an attached wire harness. Due to the oxygen sensor wire harness routing and engine vibration, the harness may become damaged over time. If the wire harness becomes damaged, the Check Engine warning lamp () may illuminate.

Lexus has designed a new oxygen sensor with a different wire harness and bracket to prevent this condition from occurring in the future.
