LED Headlight Housing Fracture & Condensation Accumulation

Service
Category Vehicle Exterior

Section Lighting (ext)

YEAR(S)	MODEL(S)	ADDITIONAL INFORMATION
2014 – 2015	IS250, IS350	VDS(s): BE1D2, BF1D2, CE1D2, CF1D2

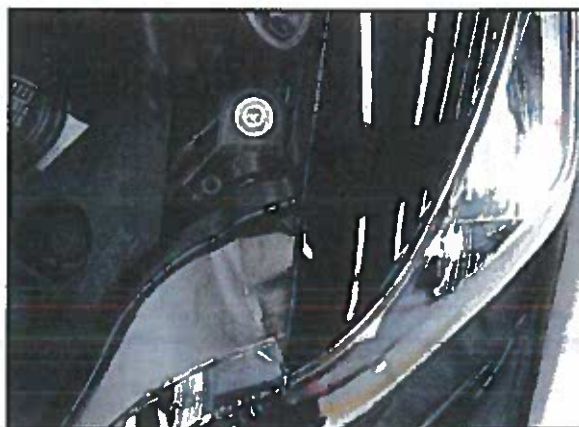
Figure 3. View of Headlight Installed in Vehicle

1 Hood to Front Fender Seal

1. Inspect BOTH headlight mounting tabs to confirm if the condition is present.
