# Service Bulletin

**Subject:** Floor/Carpet Wet at Front Passenger Side Under Dash, or at Any Front/Rear Footwell Area

**Models:** 2011-2015 Chevrolet Caprice PPV

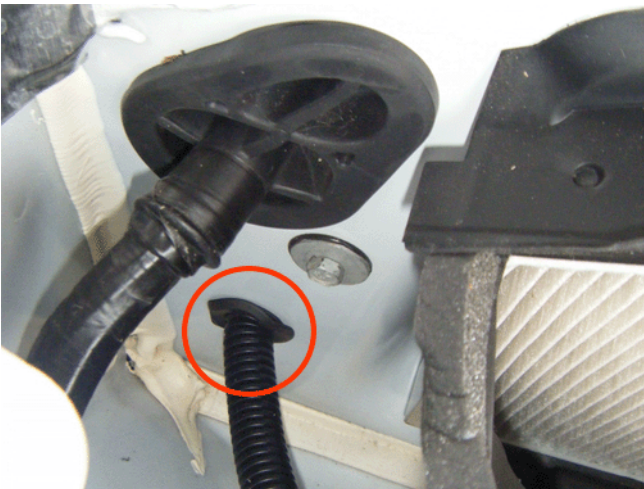
4. Inspect the cowl area outside the HVAC case for the possible existence of a wiring harness associated with certain police equipped vehicles. If equipped, the grommet/hole location for the harness will be just below the bolt (1) shown in the graphic above.

5. If equipped with the additional harness, complete the following repair steps:

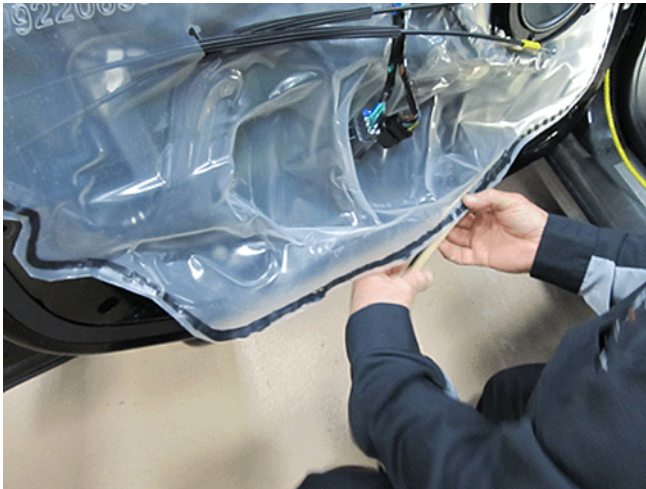
2. Inspect the door water deflector for any puckers/gaps (1) where the butyl adhesive may have pulled away from the inner door surface.

3. If puckers or gaps are evident, pull the water deflector away from the sheet metal to release the butyl adhesive along the bottom and lower corners.
4. Apply a bead of \*Kent Automotive Windshield Butyl Tape P/N P20230. or equivalent, above the existing butyl on the water deflector.
