Service Bulletin

Subject: Headliner Wet/Water Leak from Front or Rear Sunroof Glass (Replace Sunroof Window Weatherstrip/Seal)

Models: 2008-2016 Buick Enclave
2009-2016 Chevrolet Traverse
2007-2016 GMC Acadia
2007-2010 Saturn OUTLOOK

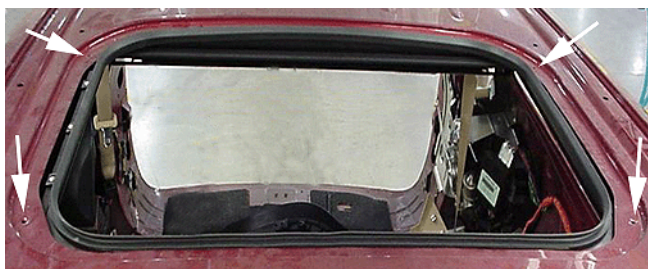
The primary cause of the leaks in this area could be a result of the rear stationary glass to body weatherstrip, front glass weatherstrip, or rear roof drains allowing too much water for the sunroof drain system to manage. When exceeding this threshold, the water overflows onto the headliner and into the vehicle.

Important: The sunroof fixed rear panel glass has been removed for illustration purposes.

Whether two or four holes are present, plug the stationary glass drain holes in the roof sheet metal using the following steps:

1. Lower the headliner following the procedure in SI.

2. Loosen the front sunroof module bolts half way. Remove the sunroof drains. Remove the remaining sunroof module bolts and lower the rear of the
