Service Bulletin

PRELIMINARY INFORMATION

Subject: Warm Air Exhausting from Driver and/or Passenger Front Seat Back into 2nd Row Seating Area Causing Occupant Discomfort

Models: 2015 Cadillac Escalade Models
2014 Chevrolet Silverado 1500
2015 Chevrolet Silverado, Suburban, Tahoe
2014 GMC Sierra 1500
2015 GMC Sierra, Yukon Models
Equipped with Heated and Cooled Seats - Driver and Passenger Front (RPO KB6)

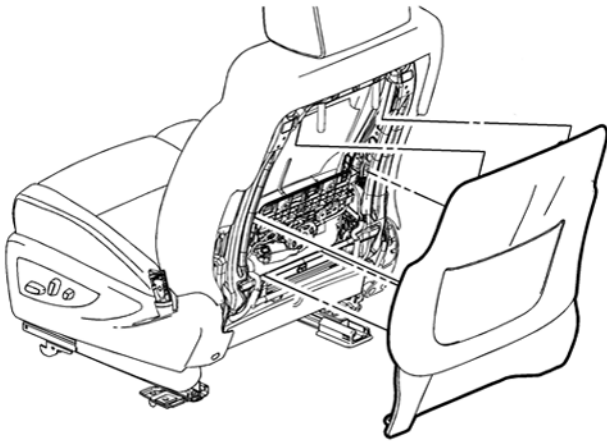
3. Grab and twist the ventilation duct to release the top and side retaining tabs (1), and remove the duct from the vehicle.

4. Reinstall the front seat back cushion finish panel. Refer to Front Seat Back Cushion Finish Panel Replacement in SI.
5. Repeat steps 1-4 on the opposite side.
