# Service Bulletin

**Subject:** Loss of High Speed GMLAN Communications, Intermittent No Crank, IP Gage Fluctuation, Intermittent Door Lock Cycling, Intermittent Chime Operation, Various IP Warning Lamps Illuminated, Transmission May Not Shift, Engine May Stall, Communication DTCs U0073, U0100, U0101, U0102, U0109, U0121 or U0140 Set (Repair Terminals in Transmission Harness Connector, Repair Open or Shorted GM High Speed LAN Circuits, Open or Shorted Data Link Resistor, Corrosion or Poor Connections in Various Control Module Connectors)

**Models:** 2007-2009 Cadillac XLR  
2007-2014 Cadillac Escalade Models  
2009-2013 Cadillac Escalade Hybrid  
2007-2013 Chevrolet Avalanche, Silverado 1500  
2007-2014 Chevrolet Corvette, Silverado 2500/3500, Suburban, Tahoe  
2008-2013 Chevrolet Silverado Hybrid, Tahoe Hybrid  
2007-2013 GMC Sierra 1500  
2007-2014 GMC Sierra 2500/3500, Yukon Models  
2008-2013 GMC Sierra Hybrid, Yukon Hybrid  
2008-2009 HUMMER H2  
Equipped With Gasoline Engine and 6 Speed Automatic Transmission 6L80 (RPO MYC) or 6L90 (RPO MYD)  
Equipped With Hybrid Propulsion (RPO HP2) and Two Mode 2ML70 Automatic Transmission

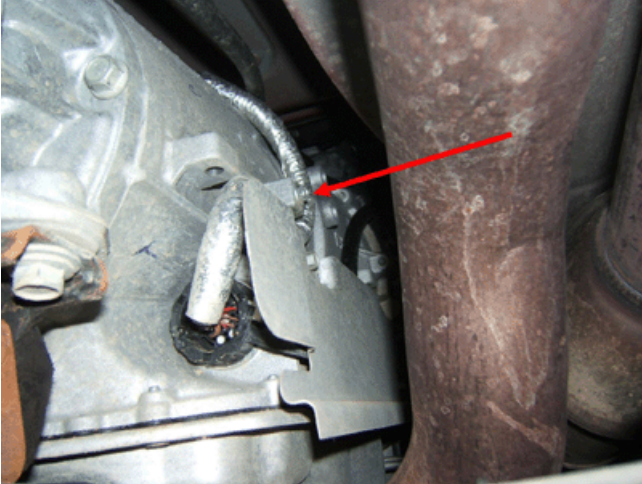
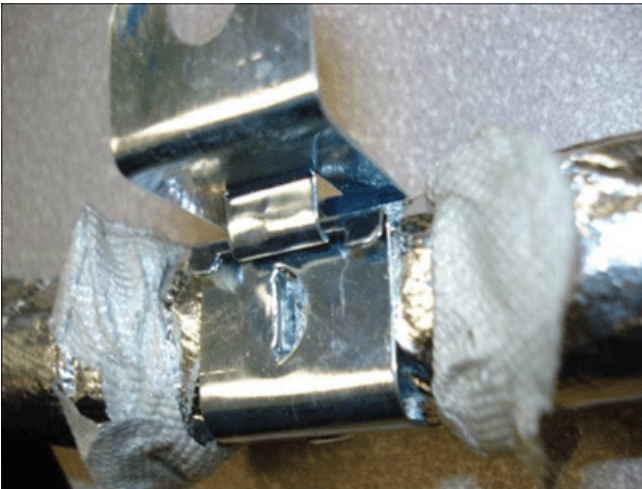
3. Locate the 16-way electrical connector on the right side of the automatic transmission as shown.
4. Inspect for chafed, damaged, pinched, open or shorted wiring within the conduit of the harness where it is secured at the transmission by a metal attachment clip as shown. Inspect any wiring harness where these metal attachment clips are used on the vehicle as needed.
  - ⇒ If the wiring is damaged, repair as needed. Refer to Power and Signal Distribution > Wiring Systems and Power Management > Diagnostic Information and Procedures in SI. Protect the conduit by covering any sharp edge with butyl tape and the conduit and wiring harness with woven polyester (PET) electrical tape. Secure the harness as needed.

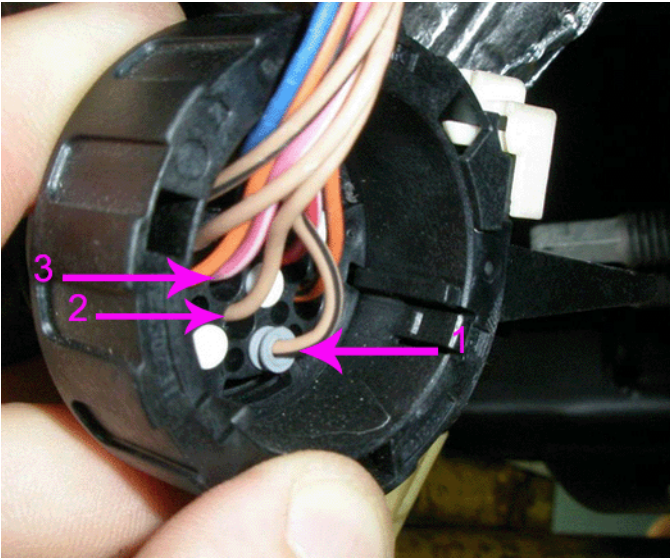
5. **Before** disconnecting the 16-way connector, **inspect** for any backed out terminals (1) as shown. Fully seated terminals (2,3) are shown for comparison.
  - 5.1. If a backed out terminal (1) is found, identify the terminal(s) on the **repair order**.
  - 5.2. Look at the connector in order to identify the number of the cavity with the backed out terminal. Refer to Wiring Systems and Power Management > Component Locator > Master Electrical Component List in SI.

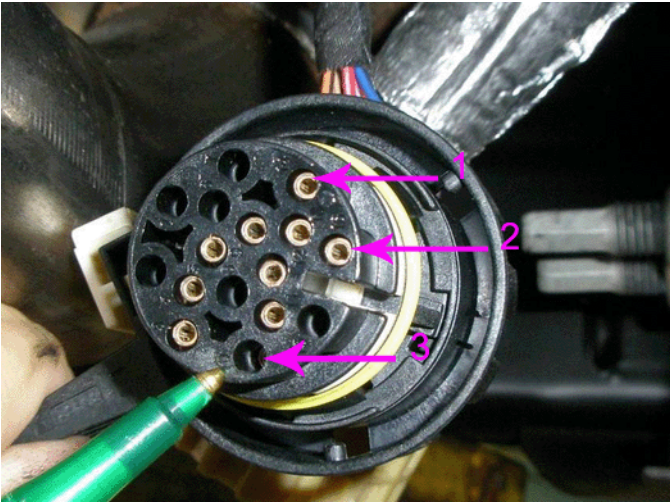
7. **Inspect** for any backed out terminals (3) as shown. Fully seated terminals (1,2) are shown for comparison.
  - 7.1. If a backed out terminal (3) is found, identify the terminal(s) on the **repair order**.
  - 7.2. Look at the connector in order to identify the number of the cavity with the backed out terminal. Refer to Wiring Systems and Power Management > Component Locator > Master Electrical Component List in SI.
8. Repair or replace the terminal(s) as necessary using the following procedure:

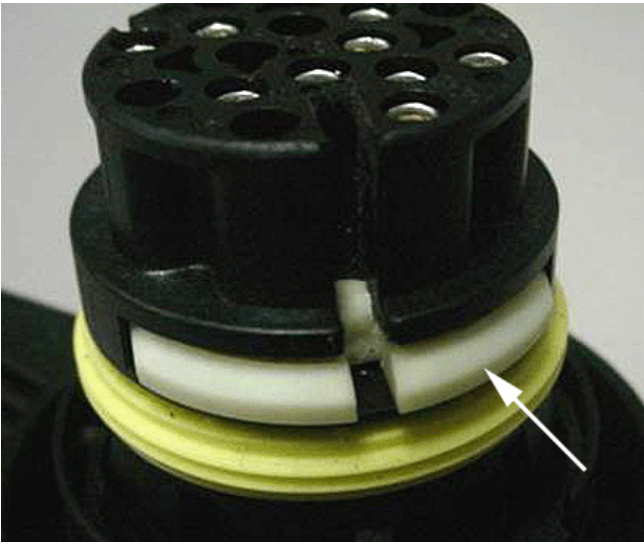
Locate the TPA lock in the reassembled transmission connector. Refer to the arrow in the illustration above, which points to a TPA lock. This one is in an unseated position. Using a small flat blade tool, push to seat the TPA until it bottoms out. Verify the TPA is fully seated.

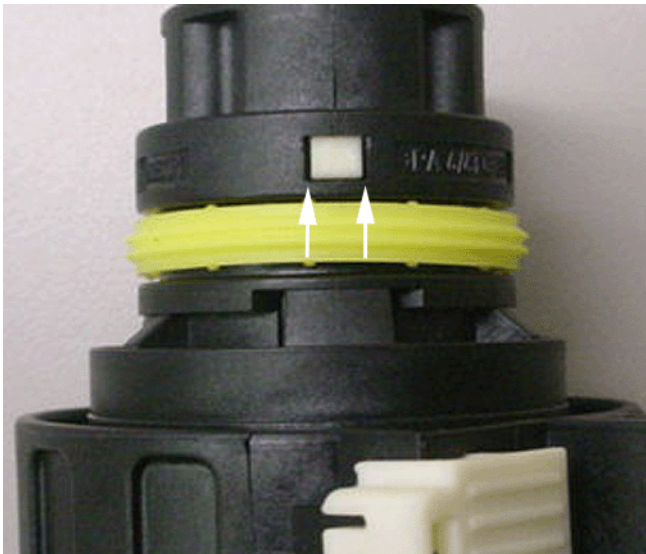
- If the TPA lock is centered in the window as shown, then it is fully seated. The gaps shown by the arrows should be even on both sides.

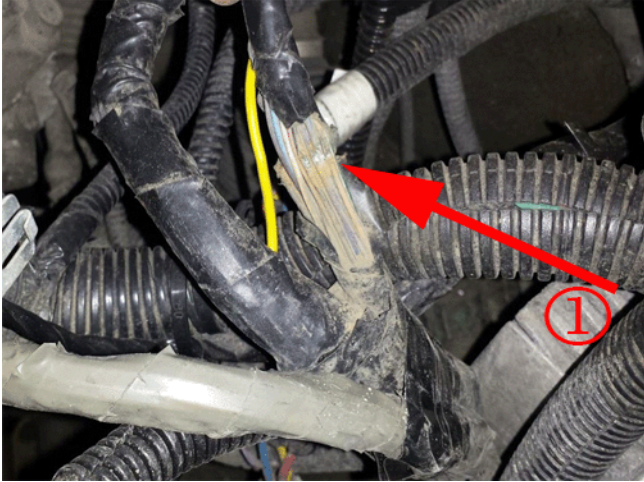
1. Engine Harness

2. Brake Pipe That's Subject to Rubbing
3. Inspect for chafed, damaged, pinched, open or shorted wiring on the engine harness in areas illustrated above.
  - ⇒ If the wiring is damaged, repair as needed. Refer to Power and Signal Distribution > Wiring Systems and Power Management > Diagnostic Information and Procedures in SI. Protect the harness by covering any sharp edge with butyl tape and the harness with woven polyester (PET) electrical tape. Secure the harness as needed.
4. Connect the negative battery cable. Refer to Battery Negative Cable Disconnection and Connection in SI.
5. Clear any DTCs that may be present with a scan tool and verify the proper operation of the vehicle.

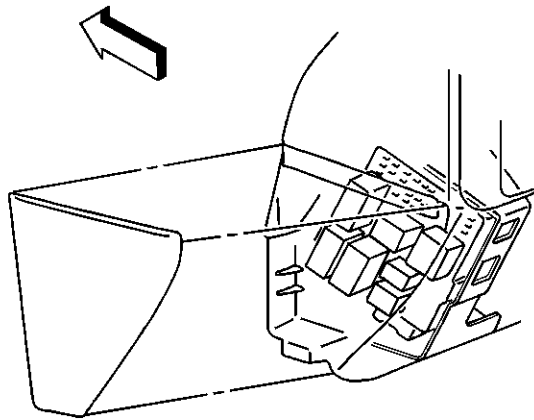
4. Inspect connector X1 (1) on the back of the fuse block for a loose connection. Secure the connector as needed.
5. Install the left side fuse block.
6. Connect the negative battery cable. Refer to Battery Negative Cable Disconnection and Connection in SI.
7. Clear any DTCs that may be present with a scan tool and verify the proper operation of the vehicle.

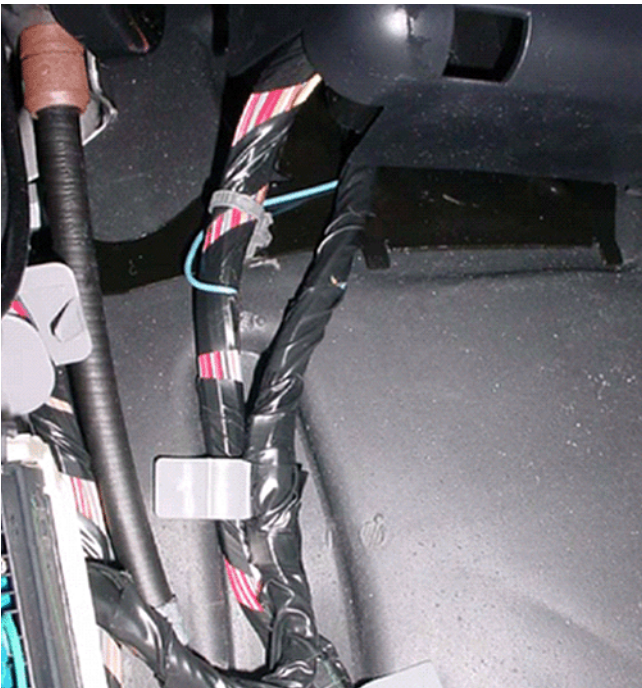
4. Inspect how the IP branch to C202 is routed. Route the harness as necessary to match the correct routing in the photo as shown. In order to route the IP harness branch correctly (behind the junction block-left I/P), remove the cover from the junction block-left I/P and unseat the junction block from the

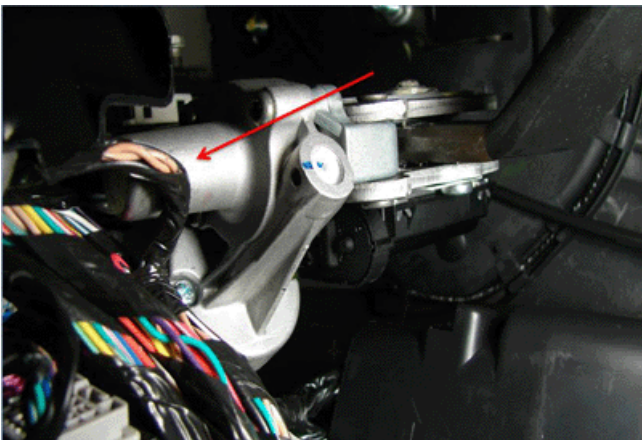
2. Inspect for chafed, damaged, pinched, open or shorted wiring at the adjustable pedals motor as shown.
3. If the wiring is damaged, repair as needed. Refer to Power and Signal Distribution > Wiring Systems and Power Management > Diagnostic Information and Procedures in SI. Protect the conduit by covering any sharp edge with butyl tape and the harness with woven polyester (PET) electrical tape. Secure the harness as needed.
4. Clear any DTCs that may be present with a scan tool and verify the proper operation of the vehicle.

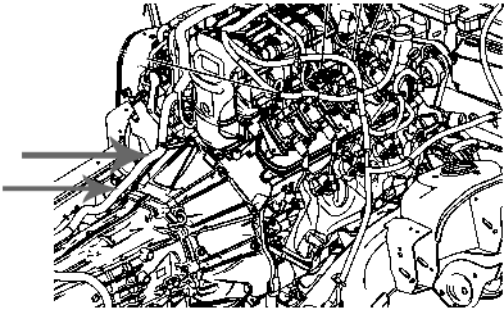
6. Lower the transmission sufficiently to provide access to the engine wiring harness where it routes from the engine intake manifold to the transmission bell housing as shown.
7. Release the wiring harness conduit from the retainers that secure it to the transmission and/or transfer case.

8. Examine the harness for wiring that may be exposed outside of the conduit. Inspect all areas for chafed, damaged, pinched, open or shorted wiring as shown. If damage to the wiring is not observed, then extract the wiring from the conduit and inspect all remaining areas as needed.

- ⇒ If the wiring is damaged, repair as needed. Refer to Power and Signal Distribution > Wiring Systems and Power Management > Diagnostic Information and Procedures > Wiring Repairs in SI. Protect the conduit by covering any sharp edge with butyl tape and the harness with woven polyester (PET) electrical tape. Secure the harness as needed.

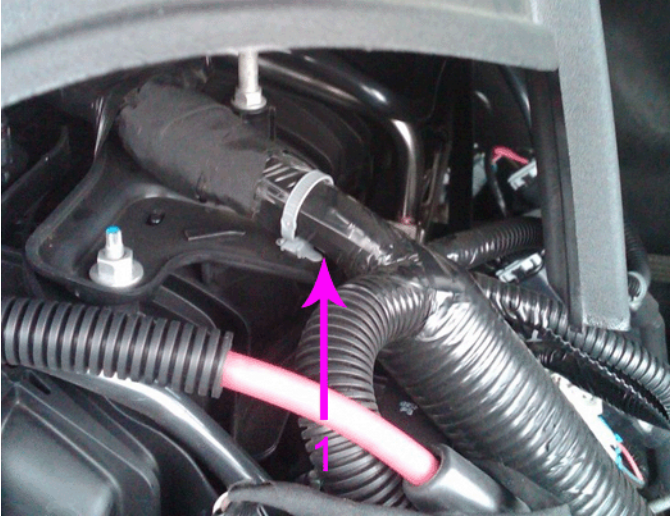
3. Locate the portion of the engine wiring harness where it branches off from the intake manifold to the ECM in the area shown (1).

4. Inspect the wiring harness for damage from contact with the steel bracket (1).
  - ⇒ If the wiring is damaged, repair as needed. Refer to Power and Signal Distribution > Wiring Systems and Power Management > Diagnostic Information and Procedures > Wiring Repairs in SI.
5. Cover any sharp edge on the bracket with butyl tape and the harness with woven polyester (PET) electrical tape.

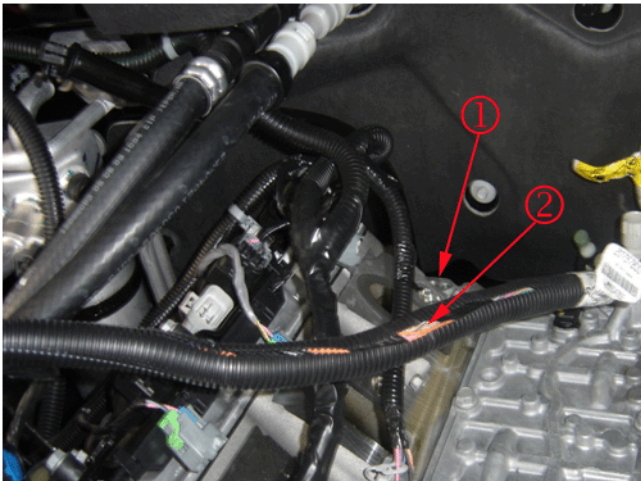
Inspect for chafed (1), damaged, pinched, open or shorted wiring. If damage is not observed, then extract the wiring from the conduit and inspect all of the remaining areas as needed.

⇒ If the wiring is damaged, repair as needed. Refer to Power and Signal Distribution > Wiring Systems and Power Management > Diagnostic Information and Procedures.

7. Protect the conduit by covering any sharp edges on the engine or transmission with butyl tape and the harness with woven polyester (PET) electrical tape.

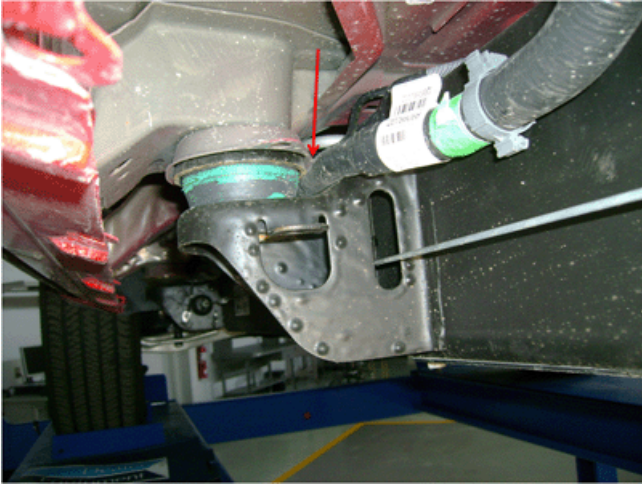
3. Inspect the wiring harness along the left side frame rail at the body mounts as shown for chafed, damaged, pinched, open or shorted wiring.
4. If the wiring is damaged, repair as needed. Refer to Power and Signal Distribution > Wiring Systems and Power Management > Diagnostic Information and Procedures. Protect the conduit by covering any sharp edge with butyl tape and the harness with woven polyester (PET) electrical tape. Secure the harness as needed.
5. Lower the vehicle.
6. Clear any DTCs that may be present with a scan tool and verify the proper operation of the vehicle.

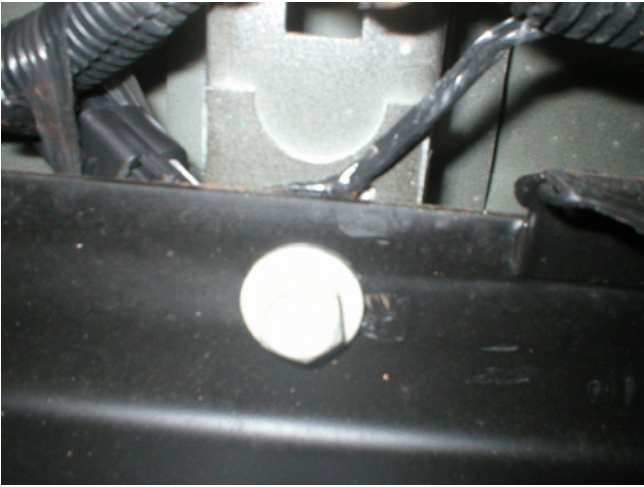
4. Inspect the wiring harness leading to the rear data link resistor 1, between the truck box and frame for chafed, damaged, pinched, open or shorted wiring as shown.

- ⇒ If the wiring is damaged, repair as needed. Refer to Power and Signal Distribution > Wiring Systems and Power Management > Diagnostic Information and Procedures. Protect the conduit by covering any sharp edge with butyl tape and the harness with woven polyester (PET) electrical tape. Secure the harness as needed. Proceed to Step 9.

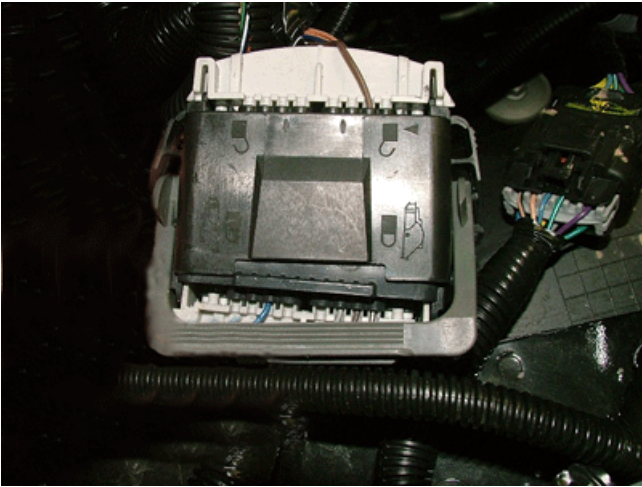
3. **Before** disconnecting, verify the connector is fully seated together even though the lever is locked down as shown.  
If the connector is not fully seated, repair as needed. Refer to Power and Signal Distribution > Wiring Systems and Power Management > Diagnostic Information and Procedures > Connector Repairs in SI.
4. Inspect the connector for the following conditions:
  - Backed out terminals
  - Bent pins
  - Corrosion
  - Poor terminal tension (use the correct test probe)

⇒ If a condition is found, repair as needed. Refer to Power and Signal Distribution > Wiring Systems and Power Management > Diagnostic Information and Procedures in SI.

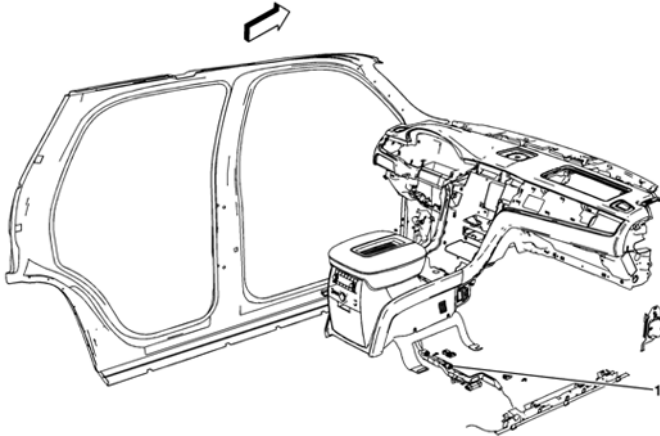
2. Inspect the harness leading to the data link resistor 2 (1) for chafed, damaged, pinched, open or shorted wiring. Refer to Power and Signal Distribution > Data Communications > Schematic and Routing Diagrams > Data Communication Schematics.

- ⇒ If the wiring is damaged, repair as needed. Refer to Power and Signal Distribution > Wiring Systems and Power Management > Diagnostic Information and Procedures. Protect the conduit by covering any sharp edge with butyl tape and the harness with woven polyester (PET) electrical tape. Secure the harness as needed.

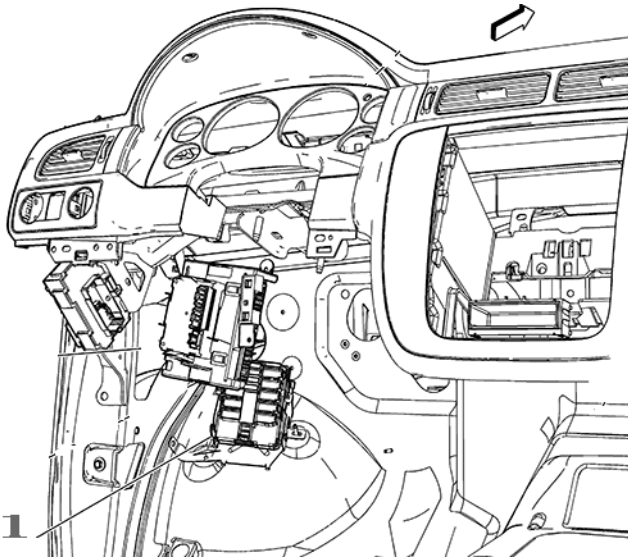
3. Locate the junction block (1) on the driver side of the vehicle under the instrument panel (IP).

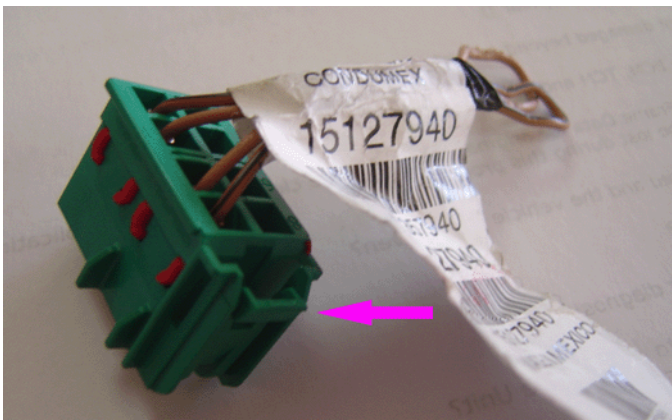
4. Locate the jumper harness loop connector that plugs into the bottom back of the junction block.

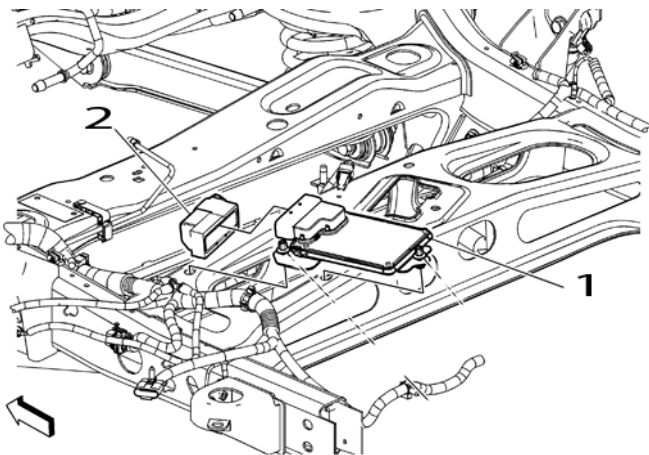
#### Typical Location of ESC Module

2. Locate the ESC module (1).
3. Disconnect the connector (2) at the ESC module (1).
