Service Bulletin

PRELIMINARY INFORMATION

Subject: Information on Vibration Analysis and Diagnostic

Models: 2014 Chevrolet Silverado 1500
 2015 Chevrolet Silverado 1500
 2014 GMC Sierra 1500
 2015 GMC Sierra 1500

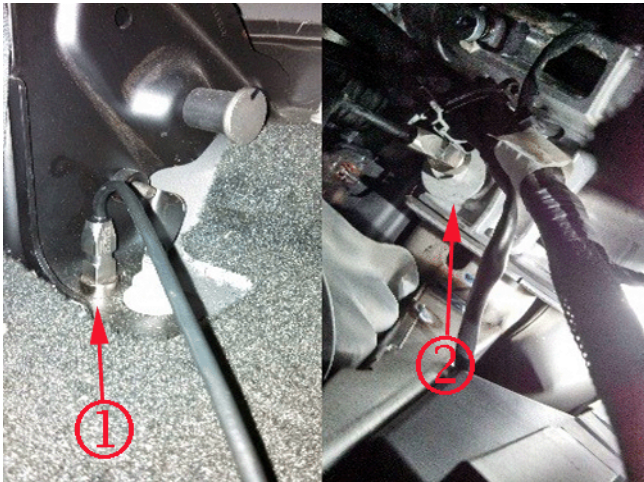
- Seat Vibration – mount the sensor to the rear seat bracket (1).
- Steering Wheel Vibration – mount the sensor to the steering wheel bracket (2) under dash.

Note: In some cases, moving the sensor from a vertical position to a horizontal position may indicate higher amplitude and may be beneficial to help in diagnosis.

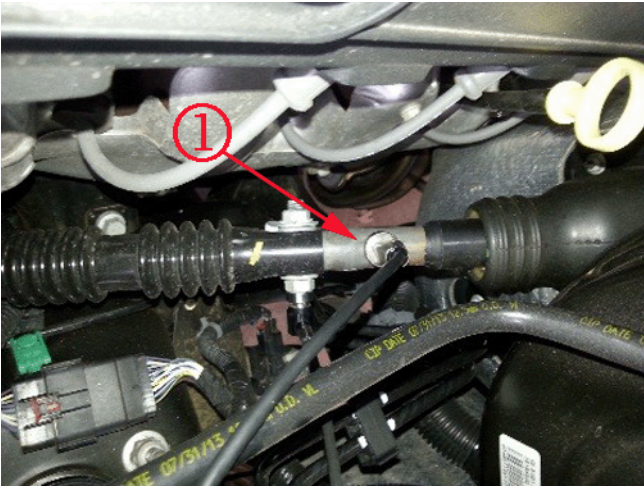
4. This step should be only be used if the vibration can be felt while running the vehicle on the rack. Mount the sensor on the steering shaft(1), under the hood as illustrated above.

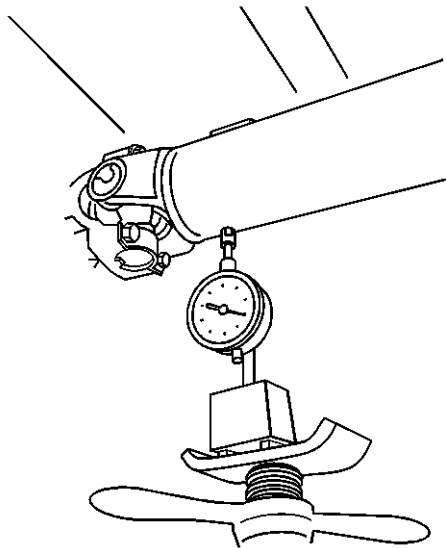
5. Mount the GE-7872 Magnetic Base Dial Indicator Set, or equivalent, or the GE-8001 Dial Indicator Set, or equivalent, to the vehicle underbody or to a service stand positioned just clear of the U-joint yoke weld on the prop shaft.

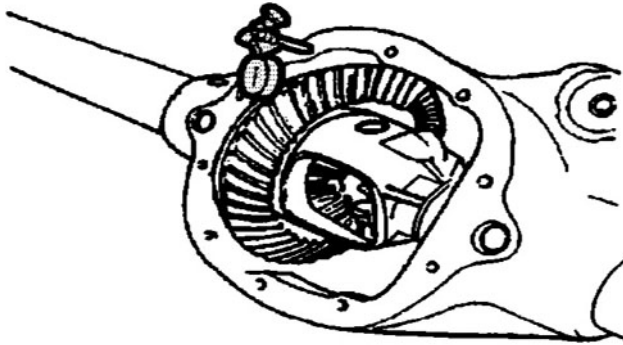
2. Install the J-25025 pins and the J-8001 indicator to the axle housing.

Note: Preload the dial of the J-8001-3 indicator approximately $\frac{3}{4}$ of a turn and zero the gauge.

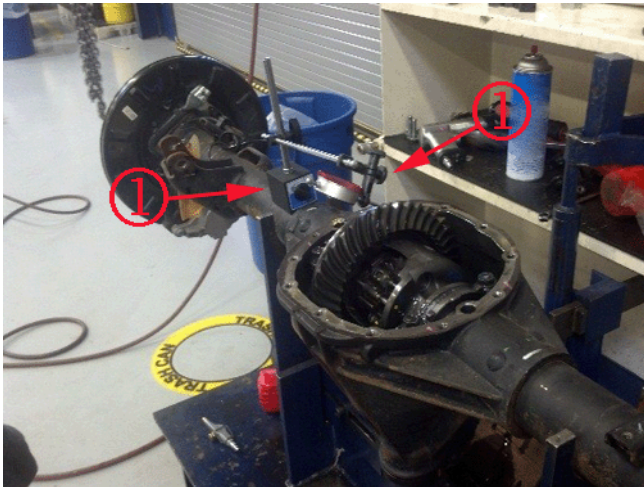
Note: The illustration above is for reference only. The differential does NOT need to be removed from the vehicle.

3. Set the J-8001-3 indicator (1) so that the stem is aligned with the gear rotation (1) and square to the tooth angle.
4. Hold the drive pinion stationary and move the ring gear back and forth.
5. Repeat the measuring procedure at **each tooth** around the ring gear.
6. The difference between the backlash at all of the measuring points should not vary by more than 0.05 mm (0.002 in).
7. If the difference between the backlash at all of the measuring points varies by more than 0.05 mm (0.002 in), inspect for burrs, a distorted case flange or uneven bolting.
8. If the difference between all the measuring points is within specifications, the backlash at the minimum lash point measured should be 0.08-0.25 mm (0.003-0.010 in) with a preferred backlash of 0.13-0.18 mm (0.005-0.007 in).

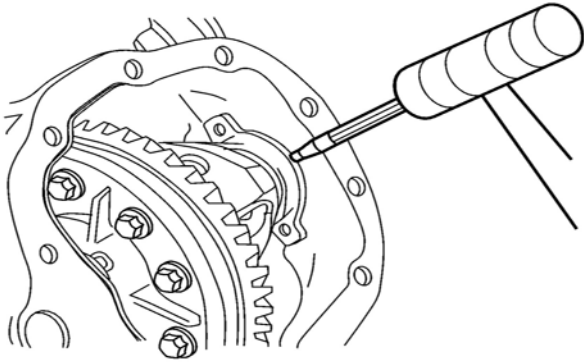
Note: The service spacers must be installed between the service shim(s) and the axle housing.

15. Using the brass drift for 9.5/9.76 axle, install the left side service spacer.
 16. Recheck the backlash and adjust, if necessary.
 17. Install the bearing caps and bolts and tighten to 85 Y (63 lb ft).
