Countries: AUSTRALIA, CANADA, TAIWAN, UNITED STATES, MEXICO, PUERTO RICO, GUAM, KOREA, SOUTH KOREA, NEW ZEALAND
Document ID: IK1201113
Availability: ISIS, FleetISIS
Revision: 13
Major System: ENGINES
Created: 4/3/2014
Current Language: English
Last Modified: 11/2/2015
Other Languages: [Español](#),
Author: Ben Krejcie
Viewed: 17323

Title: 2010 MaxxForce 11 & 13 and 2013 N13 HT EGR Core Removal/Installation

Applies To: 2010 MaxxForce11/13, 2013 N13, All Truck Models

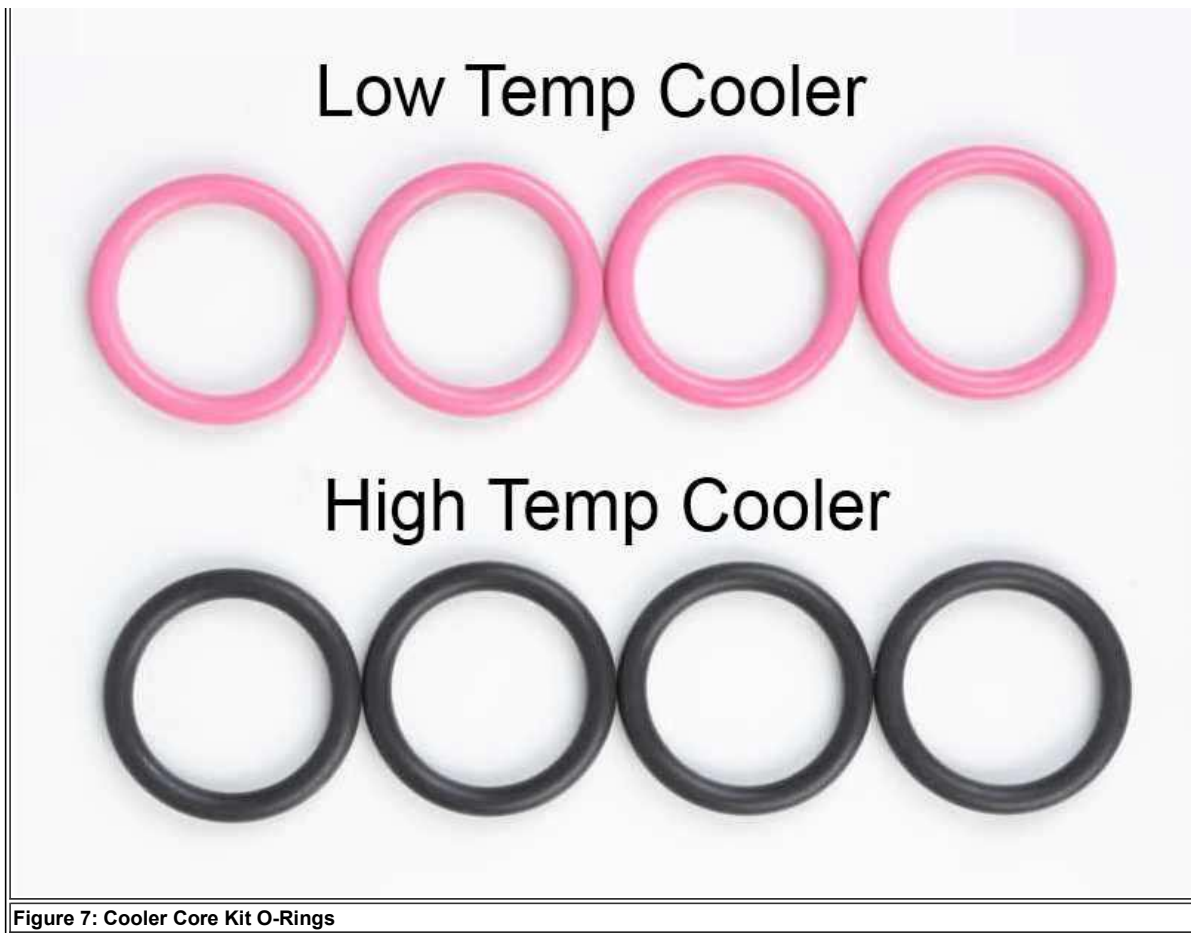
Make sure there is no debris in the o-ring grooves prior to installing the o-rings (they don't need to be spotless, just no soot chunks that will push the o-ring out of round). In development, this was the only instance of damaged o-rings (core outlet manifold cut off a section of the o-ring), outside of not actually seating them.

There are two o-ring designs and both are the same size with different durometers. Make sure to use only the black o-rings on the HT core and pink o-rings on the LT core.
